The Stained Glass Conservation of Trinity Church, Wall Street

Brianne Van Vorst and Drew Anderson

The Stained Glass Conservation of Trinity Church, Wall Street – Abstract

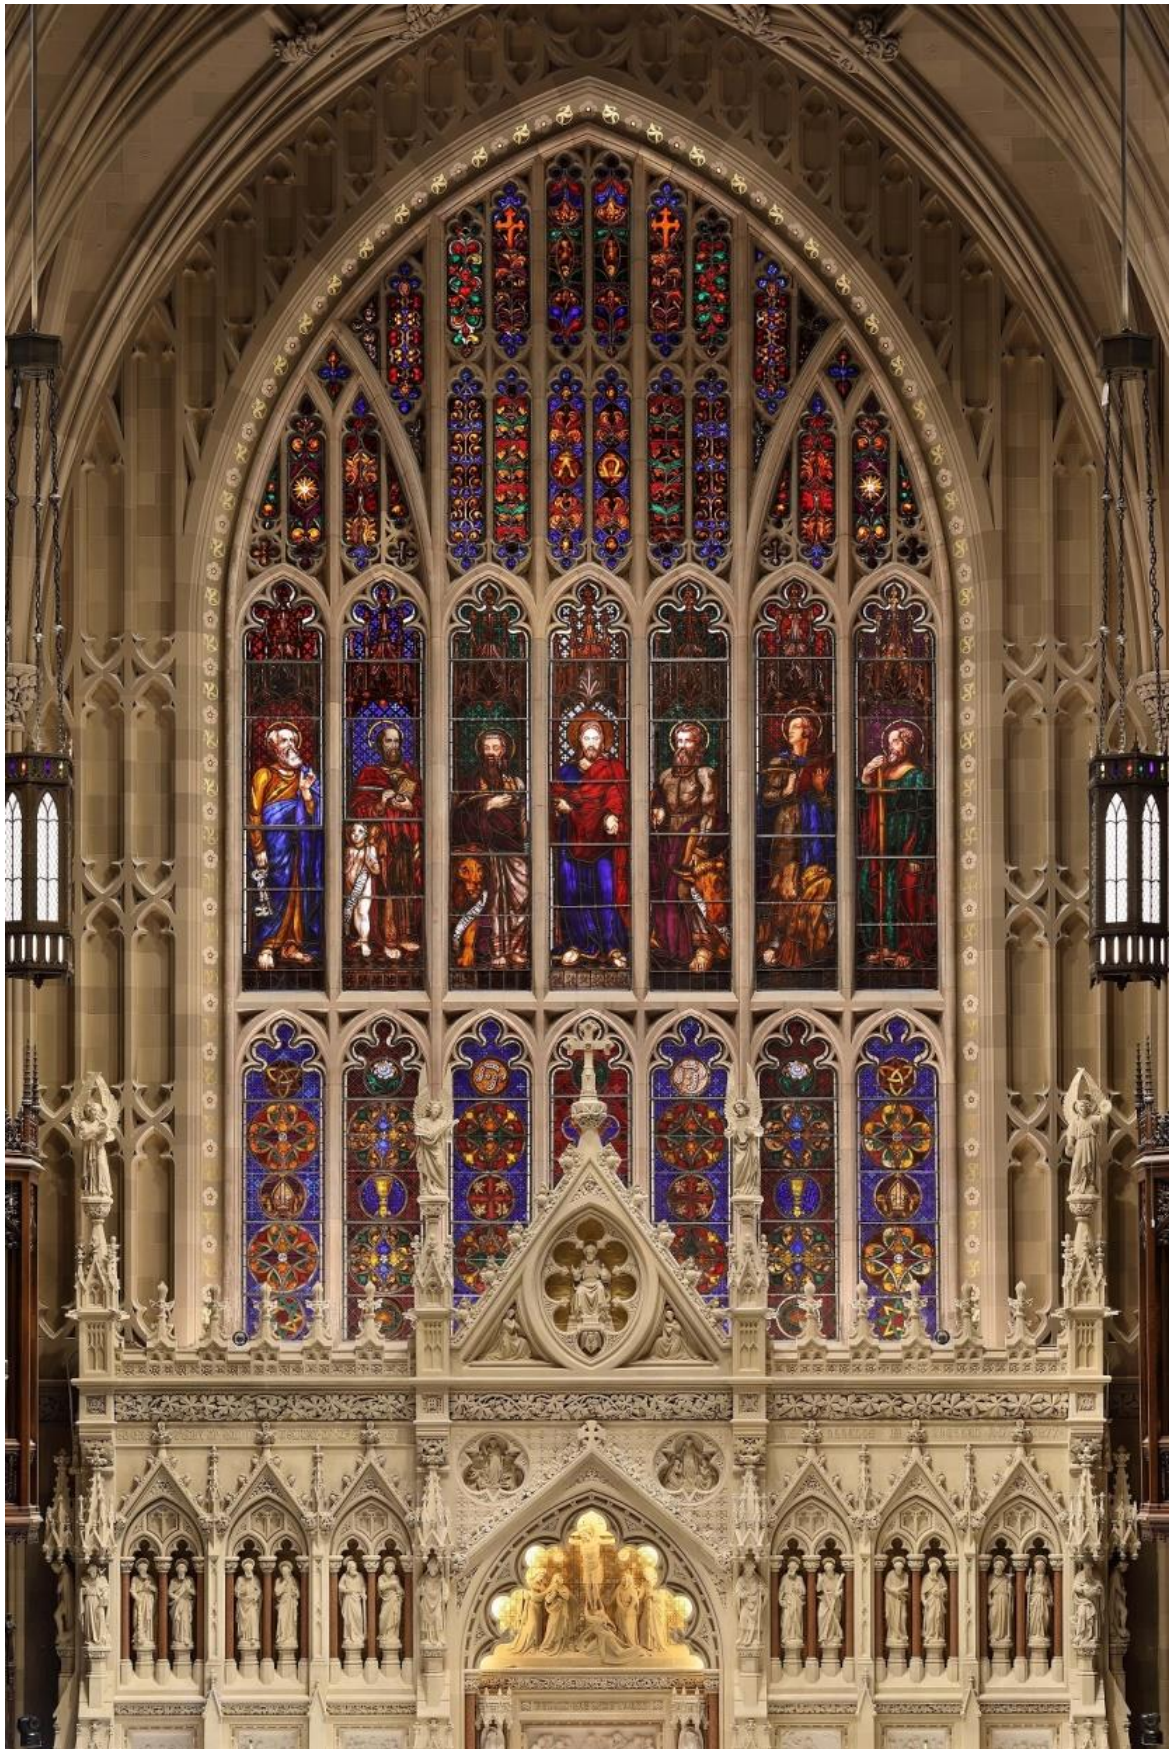
Fig. 2. Trinity Church, window C219, Chancel stained-glass window. 2020. Photograph by Whitney Cox, reprinted with permission of Trinity Church.

The multiple interventions undertaken on the Chancel window were obvious by the size and condition of the lead and further evidenced by information in the archives and graffiti on the exterior of the stained glass. Noticeable replacement pieces permeate the window, as in the example of St Matthew’s head. The window had also been cold painted on many occasions with dark paint and/or shellac. In

some areas, the cold paint was applied across the lightest areas of the window *in situ* and extended over the lead came. A photochrome from c. 1901 shows the presence of exterior glazing, suggesting that the abundance of light coming through the window required mitigation.²¹ This “smoke glass” was later removed and cold paint was applied, possibly to minimize glare. The glass paint was discovered to be fragile, and the fragility likely factored into the decision to apply cold paint in the past. The various applications of cold paint throughout the window have been affected by moisture and natural deterioration, causing a blotchy and inconsistent appearance.

All Chancel panels were abated and removed for treatment. Once the panels were brought to the studio for conservation, it became apparent that the mixture of glazing cement used was extremely hard. Ultimately, the safest way forward was through partial releading. Only areas with the most severe mending leads or poorly painted restoration pieces were dismantled for treatment. Thick mending leads were removed and edge-bonding was used as often as possible.

Consideration was given to removing the cold paint because it was unoriginal, heavily applied and flaking off. Philosophically, it was concluded that removing the cold paint would not return the window to its original design. The Chancel window has been darkened since its inception by various methods and removing the cold paint may eliminate the familiarity and identity of the window. From a technical standpoint, intervention was unsafe for the underlying glass paint. Solvents and mechanical means were tested for possible removal. We concluded that the removal of the cold paint could also remove the underlying glass paint, which in some cases was fragile. In order not to cause damage, the cold paint was

left intact. The existing, unoriginal fillet borders were replaced with antique glass lightly matted, to renew the original appearance of the border glass.

The immense value of this window to American stained glass heritage coupled with its fragile paint qualified it for environmental protection in the form of an internally ventilated protective glazing system. This system will prevent the formation of damaging cycles of condensation on the original glass, as well as protect the original glass from mechanical and atmospheric damage, maximizing its longevity.

The environmental protection includes ¾" heat-strengthened laminated glass set into the original glazing groove. The original stained glass panels are framed in bronze and brought slightly forward to create an interspace, mechanically fastened with screws to the interior stone jambs. Lead light shields obscure any light leaks. New bronze interior support bars remain at stack joints. Saddle bars were eliminated in areas where they were not attached to lead joints and obscured the design. Exterior bronze fins were added in their place for support.

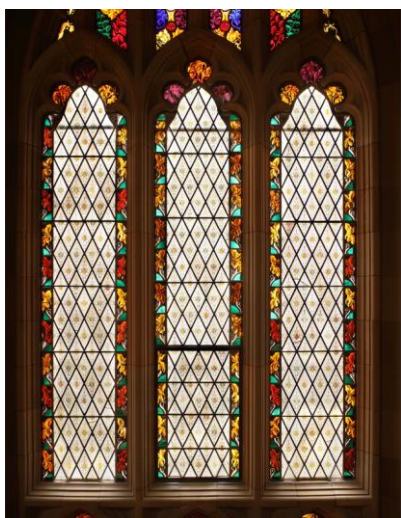
Fig. 3. Trinity Church, window A111, stained-glass aisle window. 2019. Photograph by Whitney Cox, reprinted with permission of Trinity Church.

The formulaic design of the sixteen aisle windows contain a printed quarry field within each lancet, surrounded by vertical colored borders (fig. 3). The quarries are colorless glass with an ornamental pineapple or pinecone, perhaps a bulb flower, with a small amount of silverstain in the center. The borders are comprised of various types of foliage, each section containing a colored accent piece. Every window has a unique tracery filled with jewel-toned colored glass painted with foliage and Christian symbols. The silverstain varies from pale yellow to rich amber throughout. It is noteworthy that the original aisle scheme still exists at Trinity. Diamond glazing is traditionally undervalued in the United States and has often been replaced with opalescent memorial windows in the early 20th century when the work of

Despite their previous re-leading, the aisle panels exhibited bowing in many places. Exterior bars were retroactively soldered onto the matrix but were not set into the stone and were not providing adequate support. The extent of previous repairs in the aisle windows varies from the sporadic replacement of individual pieces to the complete replacement of entire panels. Due to poor execution, some of the replacement pieces are easily identifiable, while others closely replicate the original pieces. Previous restorers repurposed quarries, often joining two different halves together with lead. There were many cumbersome mending leads. The south side of the aisle has typically been restored more often. Inconsistencies within the quarry design illustrate different hands at work during multiple restorations.

Another notable aspect of the aisle windows is what we referred to as the “shoulder piece.” In nearly all of the panels, the corner quarries at the stone cusps were broken (likely during past removals) and a replacement piece inserted. In most cases, the replacement piece was clear glass with matte heavily applied; in a few cases, there was a re-purposed quarry. We do not know if the shoulder pieces were originally a continuation of the quarry design or the border design.

After abatement and removal, the paint stability of each aisle panel was tested. Dismantling allowed access to the multitude of early lead repairs and poor replacement pieces within the center of the panels. After dismantling, both sides of the windows were gently cleaned with deionized water and cotton wool swabs. Pieces containing unstable paint were cleaned on the exterior non-painted side, and any stubborn putty was carefully mechanically removed.

Only the poorest painted restoration pieces (quarries of the wrong color glass or design) were replaced with appropriate substitutions. Thick mending leads were removed, and the glass was bonded using epoxy Hxtal NYI-1 and neutral cure silicone as often as feasible. Copper foil was introduced when bonding was not possible, and in some cases lead repairs were reintroduced. For example, where two

The panels were re-leaded with the same size and profile as the existing lead came and steel rebar was inserted next to the heart in the two vertical leads between the quarries and borders for additional support.

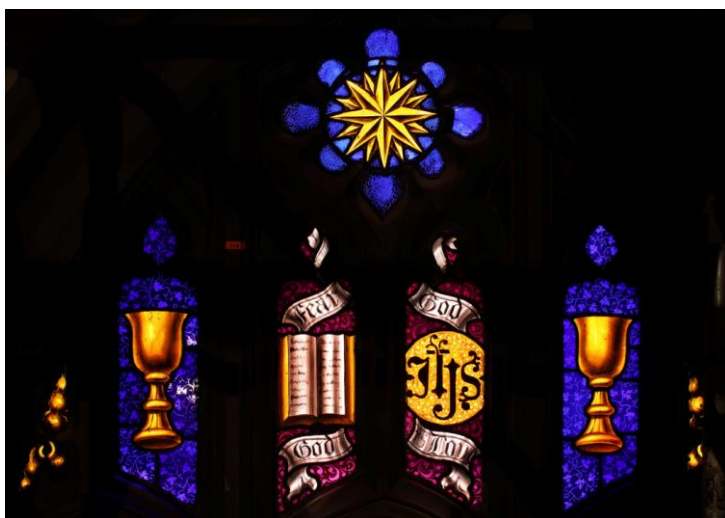
Fig. 4. Trinity Church, window B208, clerestory tracery, 2018. Photograph by Whitney Cox, reprinted with permission of Trinity Church.

The original clerestory lancets were replaced in 1967. Documentation in the Trinity archives from 1932 provides evidence of paint loss to lancets within the clerestory level,¹² further substantiated by a 1967 unpublished research paper.¹³ It is assumed that the aesthetic ramifications of paint failure triggered the replacement of the clerestory lancets. Only the original clerestory tracery glass survives and, like the aisle, is jewel-toned in color and painted with foliage and Christian symbols (fig. 4).

Like the aisle, areas of the clerestory tracery had been restored multiple times. Given the height of the nave and documentation in the archives, work undertaken on the clerestory windows was done from the exterior side aisle roof. The four bays on the west end of the church do not have an aisle roof underneath the clerestory level. Thus, windows 208-211 were not accessible from the exterior and escaped restoration since their original installation. These are the only four tracery openings containing original lead.

The lack of proper interior access coupled with breakage resulting from stone movement led to dozens of replacement pieces and unsatisfactory repairs throughout the clerestory tracery. Aside from the small amount of original lead, the rest of the clerestory tracery was releaded in the 1940s and 1990s. The 1990s restoration entirely replaced approximately 13 panels. Regrettably, the replacement panels were made significantly smaller than their openings. Other panels treated during the 1990s restoration campaign used a combination of original glass and replacement pieces.

Clerestory tracery panels with very minimal damage, including those in their original leading, remained *in situ* for treatment to avoid abatement. Panels that required significant conservation were abated and removed. The 1990s-made panels that were too small for their settings were removed and cleaned. Additional perimeter lead came was added to ensure the window fit properly into the groove. The 1840s panels that were severely broken were removed for treatment. Individual pieces were extracted and repaired without re-leading where possible. When the breakage or missing glass was severe, the panels were dismantled, treated and releaded with the same size and profile as was existing. The clerestory tracery panels received the same protective glazing treatment as the aisle windows.
