The Inherited Condition: The Complex Methodology Required to Conserve the West Choir Windows of Naumburg Cathedral, Germany

The Inherited Condition: The Complex Methodology Required to Conserve the West Choir Windows of Naumburg Cathedral, Germany – Abstract

This paper will describe the restoration history and the balanced methodology required to unify these windows, whilst addressing the urgent interventions needed for their conservation.

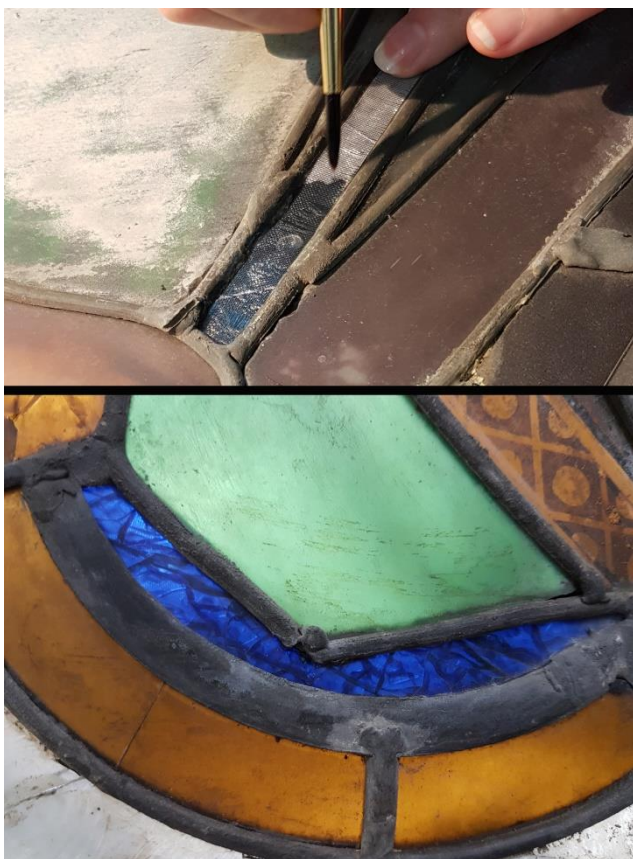
Fig.3. Craquelé consolidation technique and post treatment result in nwlll 2a
© Vereinigte Domstifter.

At Naumburg, the craquelé can be attributed to low lime glass degradation and the LLHA (low lime high alkali) composition of the glass. This weakness, combined with high pollution and a damp environment resulted in the degradation. Calcium content is recognised as an important factor in the durability of glass, as it appears to slow the leeching of alkalis via hydrolysis. The most resilient glasses contain over 10% calcium,²⁶ whereas a sample of blue craquelé contained 6.78% calcium (and 25.44% combined Na and K).²⁷ Similarly, EDX analysis found a sample of amber yellow contained 6.34% calcium (and 27.19% total alkali). Both results fit within the anticipated parameters for vulnerable glasses.

The craquelé process witnessed in Naumburg corroborates other descriptions of this phenomenon. The leeching of alkalis resulted in an efflorescence of sodium sulfate salts.²⁸ The glass surface developed micro-cracks, allowing water to penetrate deeper, causing the bulk glass to fragment. As well as environmental control, we researched consolidation methods, including the work of Marie Stumpf at the Burrell, Merlyn Griffiths at YGT, and the DBU project at the Cologne Dombauhütte.

At Cologne, they attached glass fibre material to the surface using either Ormocer or Paraloid B72. Both were found to be similarly effective and durable.²⁹ Building on their results, we conducted trials using glass fibre webbing with HXTAL and silane, and Paraloid B72 in ethyl acetate. Paraloid provided the best results.

The webbing was treated with a 10% coating of B72, to provide rigidity for measuring and cutting. A solution of 25% B72 in was applied to the exterior side of the breaks. The webbing was then adhered to this surface, with the 25% solution (fig. 3). Gaps were filled with B72 (or Araldite 2020, if the hole was larger than a Euro coin) and retouched with acrylics. We ensured the webbing did not adhere to the

lead, as the differing thermal expansion rates of these materials could potentially damage the B72 film. The results were aesthetically satisfying, with the webbing undetectable from the interior side, and robust enough to retain these pieces.

As Paraloid B72 is known to fail in high humidity, this technique can be used only with internally ventilated protective glazing. In 2017, this technique was trialled in the West Choir by Derix, Taunusstein. This test panel has been monitored regularly over the last 4 years. The repairs remain stable, with no loss of adhesion or blistering in the webbing's surface.

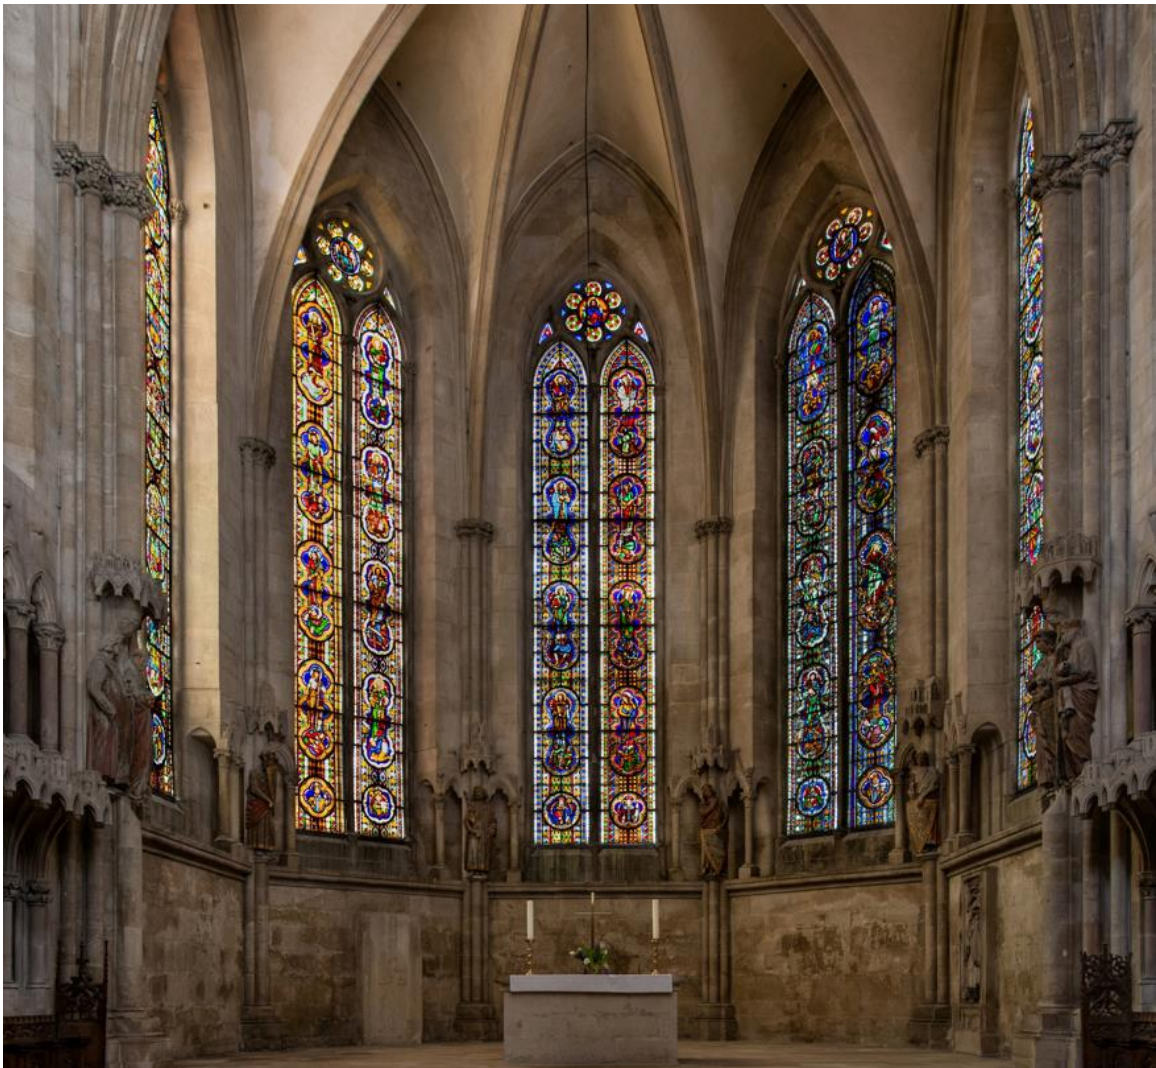
Fig. 4. The West Choir Windows post conservation, in 2020. © Vereinigte Domstifter.

Our methodology prioritised the immediate conservation needs of the windows. We also returned legibility to the iconography and replaced missing details with plates and infills. We stabilised the medieval glass and retained the 19th-century craquelé. All five windows are now protected with UV-filtered weathertight protective glazing and the disparity of light has been softened by the careful application of paint (fig. 4).
