## Finding Faces: Reconstructing Liturgical Identity in the Medieval West Choir Windows at Naumburg Cathedral, Germany

Emily Yates, Sarah Jarron, Mayre Maquiné, Jana Hildebrandt

### *Finding Faces: Reconstructing Liturgical Identity in the Medieval West Choir Windows at Naumburg Cathedral, Germany – Abstract*

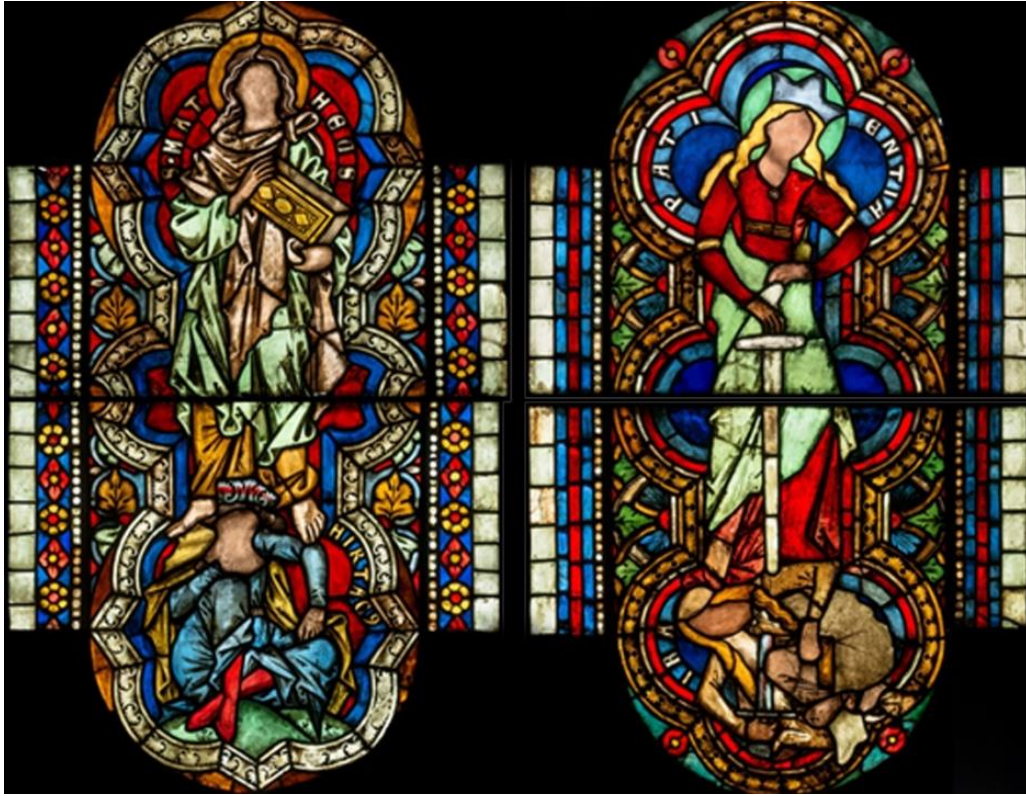
Fig. 1. Naumburg, Cathedral, nwll: 'Cloud Heads' in panels 7a, 8a, 7b and 8b, 1250/1941/1967. © Holger Kupfer.

Between 1959 and 1967, seven more heads were replaced with neutral infills.

It is unclear if Oberberger's neutral head in the figure of St Matthew, signed and dated in 1941, was part of a test panel for a solution which may have later been abandoned or if he would have treated all of Memminger and Franke's additions in this way had the war not interrupted the work. Nonetheless, it is evident that concerns about integrity, honesty and falsification directed Heinz Hajna's approach, as seven more neutrally toned heads, along with numerous undetailed inserts in place of hands, drapery and other elements, were inserted across the medieval windows north west II and III, and south west III between 1959 and 1967 (fig.1). The effect this had on the iconographic readability and aesthetic appearance of the windows was devastating.

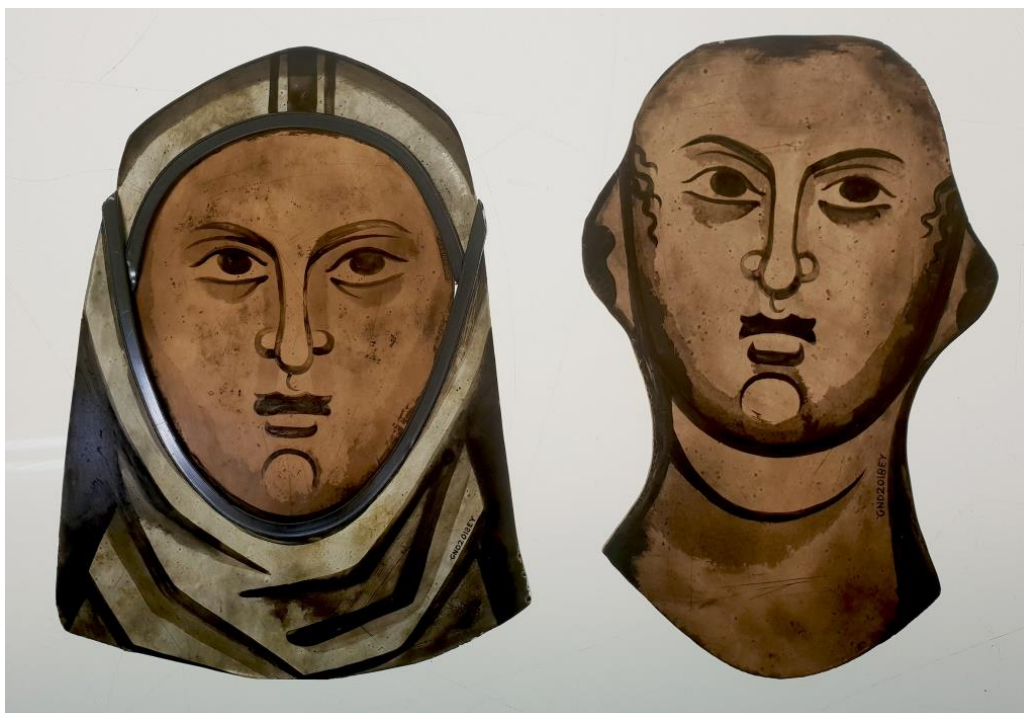
Fig. 2. Naumburg, Cathedral, nwIII: the 'Naumburg Style', St Elizabeth and St Demetrius, 2018. © Vereinigte Domstifter.

In order to replicate it, the patterns and similarities in the surviving faces were closely examined. It was discovered that the distances between the eyes, the length of the nose and width of the mouth all tended to fall within a certain range, roughly corresponding to a template. The eyes conformed to a certain shape and line style and the eyebrows were almost always the same width, thickness and line weight. This made it possible to re-imagine the lost faces according to a specific set of rules (fig. 2). The reconstructions cannot decisively predict the exact appearance or placement of lost features, but they can give an informed impression of how a head painted for the original Naumburg scheme may have looked. Furthermore, each new infill remains fully reversible.<sup>10</sup>

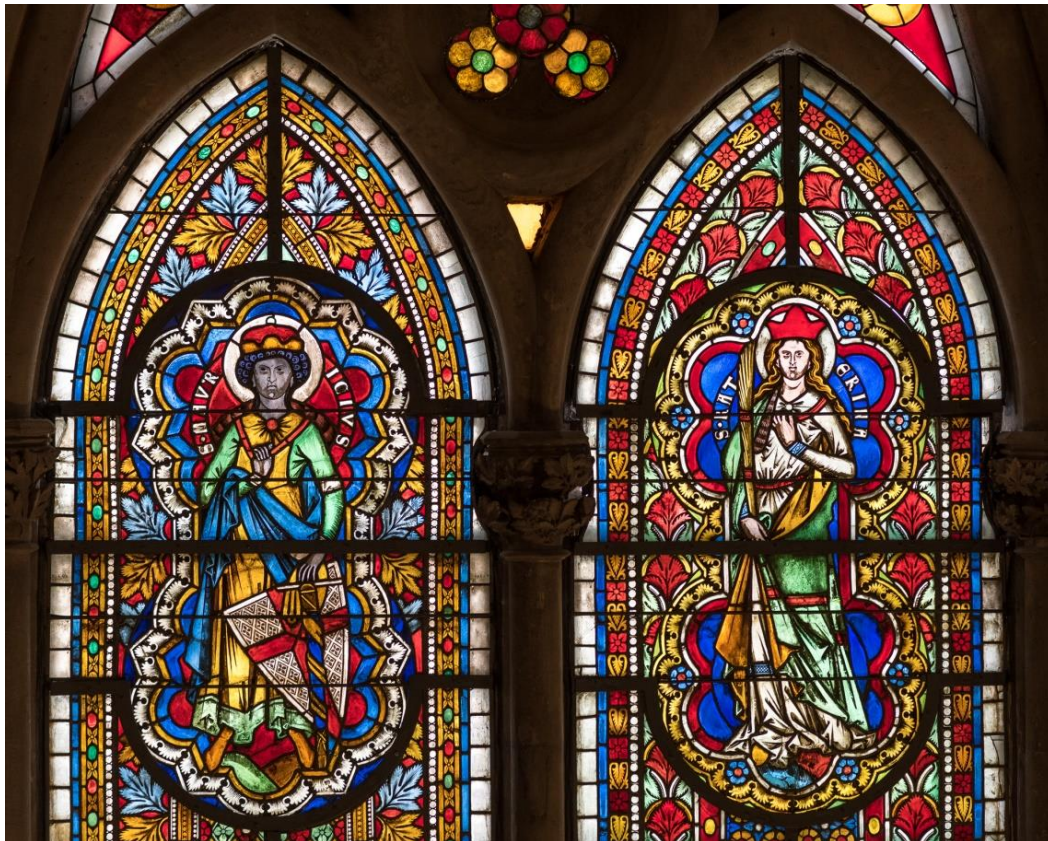
Fig. 3. Naumburg, Cathedral, nwIII: St Mauritius (with new head) and St Catherine, 1250/2018. © P. Hildebrand.

In order to stay in line with our concept and to maintain our aim of providing sensitive reconstructions in the 'Naumburg Style', the new head of St Mauritius was developed in accordance with our model. The glass colour for the figure was matched as accurately as possible to the surviving medieval material but no attempt was made to differentiate the facial characteristics from the stylistic rules we had already established (fig. 3).
