A New Isothermal System that Avoids the Cold Bridge between the External and Internal Glazing (A Solution Specifically Designed for Extreme Weather Conditions)

Isothermal Glazing in Shetland

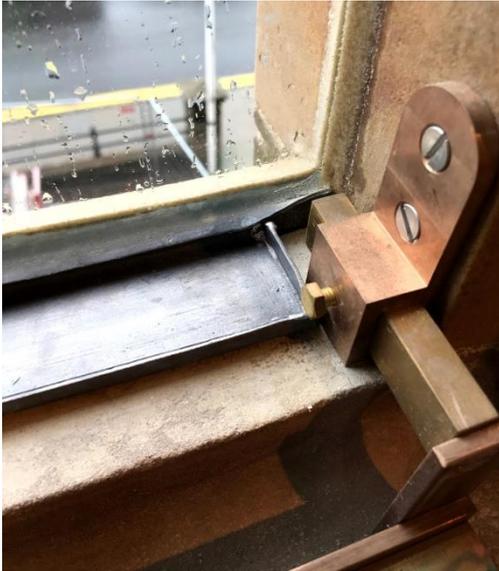
Fig. 1. Lerwick Town Hall, Shetland, west elevation detail showing external glazing, mortar covered with burnt sand mastic “skin”, bottom slide bar system placed vertically on stone cill, the leg extension to accommodate any overall height changes, and the lead condensate tray, 2017. © Cannon-Maclnnes.

Two different types of precision-cut, slide-bar units were designed and made for Cannon-MacInnes by the engineering firm: one type for the bottom cill (fig. 1), which could be used either vertically or horizontally next to the stonework; and one type for each panel separation going vertically up each lancet (fig. 2). The stone was carefully drilled, and the 'slide units' were attached to the stone in-goes, using high quality marine stainless-steel screws, embedded in a good German nylon/plastic fitting. The new stonework was often wet as the protective scaffold covering was constantly shredding and being blown across the North Sea to Norway. This alone made installation difficult. Care had to be taken with the drilling of holes into the new sandstone to avoid shaling.

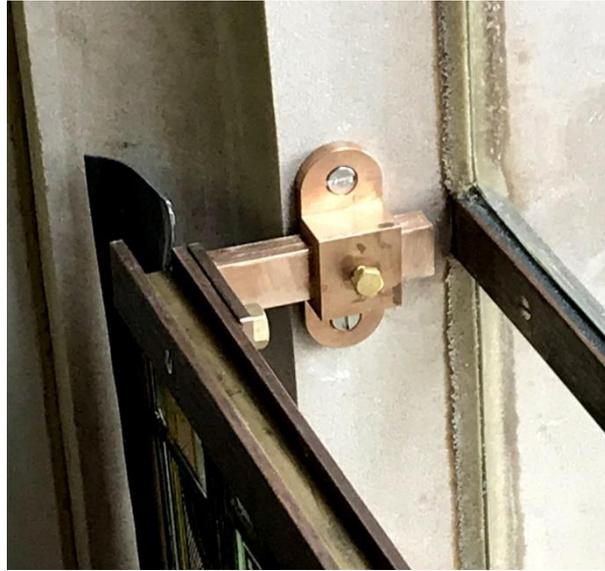
Fig. 2. Lerwick Town Hall, Shetland, west elevation detail showing external glazing, mortar covered with burnt sand mastic “skin”, vertical slide bar system placed vertically on new stone mullion, the manganese bronze support bar, and a fully conserved “middle” panel in place, 2017. © Cannon-Maclnnes.

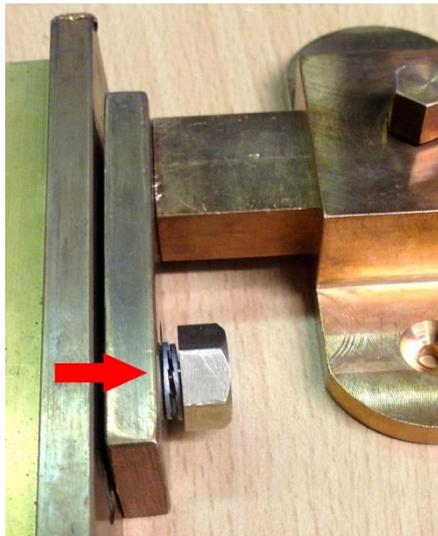
Fig. 3. Lerwick Town Hall, Shetland, detail showing “Nordlock” washers in place within the vertical slide bar system. One pair of washers on each side of the panel ensures the bar will not slip, 2017. © Cannon-Maclnnes.

Each panel was installed in the same way, using one bar top and bottom, and two sliding units, each on either side. The Nordlock washers ensured there was absolutely no slippage once each panel was securely placed in situ (fig.3). Positioning one set of washers on either side of each panel guaranteed that if one washer ever slipped slightly, the opposite set would automatically tighten. Each bar was easily strong enough to bear an adult’s weight on with no apparent effect. We had confidence in installing each panel either from the top down, or the bottom up.

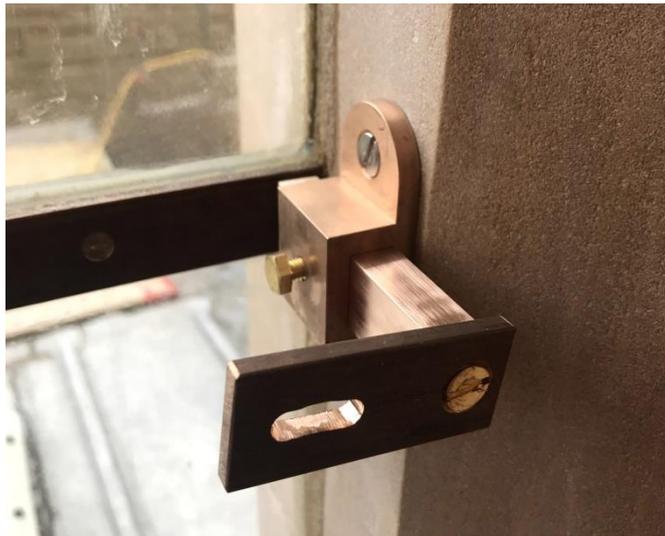
Fig. 4. Lerwick Town Hall, Shetland, south elevation detail showing the internal slide bar, which allows the whole system to be finely tuned to fit perfectly. Each panel can be adjusted on site, slightly up, down, in, out, right or left, 2017. © Cannon-Maclnnes.

On site, further additions were manufactured to the scheme as required; standard horizontal slot-plates which allowed slight lateral and height movement to visually match the external and internal barring (fig.4), and bespoke vertical slot-plates on the bottom unit, to match the depth of the curved cill. Each additional slot plate was secured using a standard ribbed bronze washer.
