**Preserving Identity**

**11th Forum for the Conservation and  
Technology of Historic Stained Glass  
Girona – Barcelona, 7–9 July 2022**

**Organized by the Catalan Committee  
of the Corpus Vitrearum  
in Association with the  
International Scientific Committee for the  
Conservation of Stained Glass (ISCCSG)**

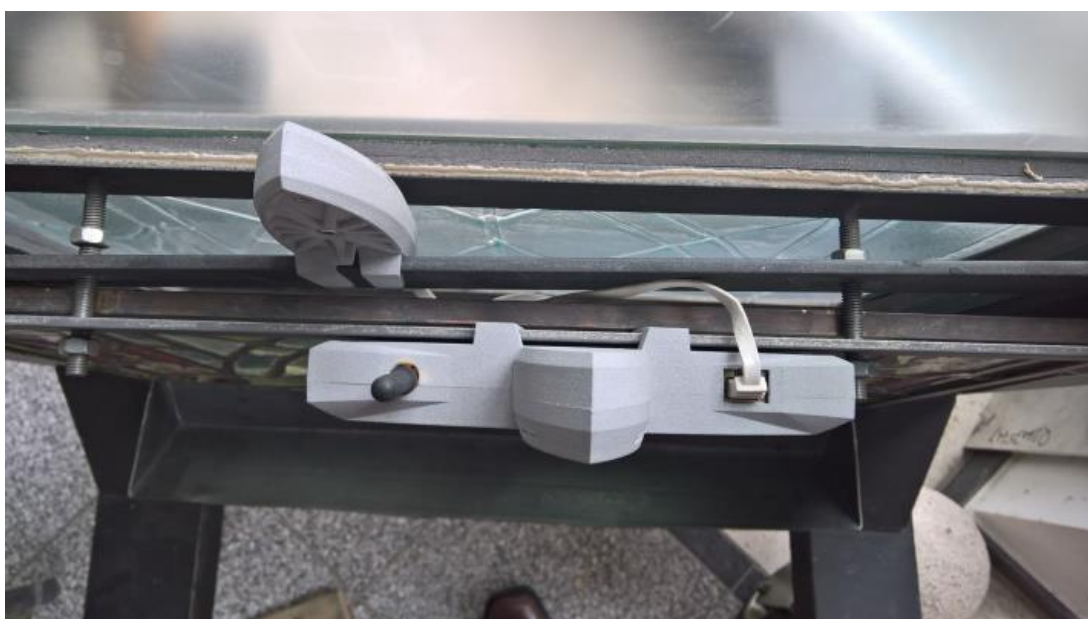
Abb. 3. Custos Aeris für die Dauerüberwachung der thermodynamischen Zustände von Original- und Schutzverglasung.

Mit diesem System werden Lufttemperaturen und relative Feuchten im Luftspalt und im Nahfeld der Originalverglasung auf der kircheninneren Seite gemessen. Darüber hinaus findet eine berührungslose Oberflächentemperaturmessung der Originalverglasung auf der kircheninneren Seite und auf der Luftspaltseite statt, sowie auf der Luftspaltseite der Schutzverglasung. Damit sind alle relevanten Größen für die oben dargestellte Überwachung von Grenzwerten vorhanden. Für die Auswertung und Darstellung von Gefahren werden bisher schon die Angaben zur Tauwasserbildung auf Original- und Schutzverglasung in % der gesamten Messzeit gemacht (Abb. 4). Rot bedeutet, daß Kondensat vorlag und grün bedeutet, daß die Verglasung kondensatfrei war.

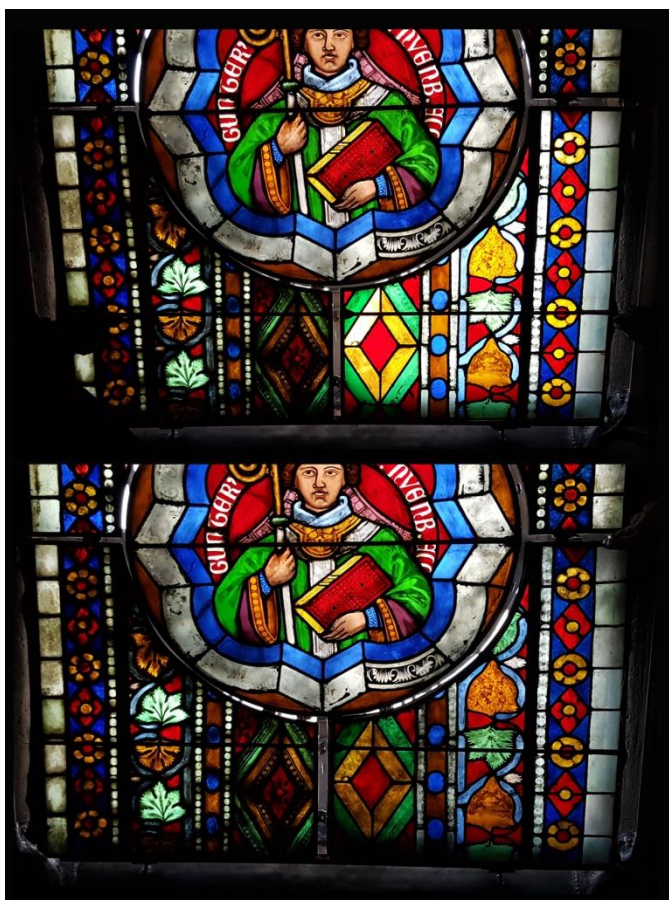
Fig. 2. Naumburg Cathedral: Before and after installation of the darkening plate for panel nwll 1a1.

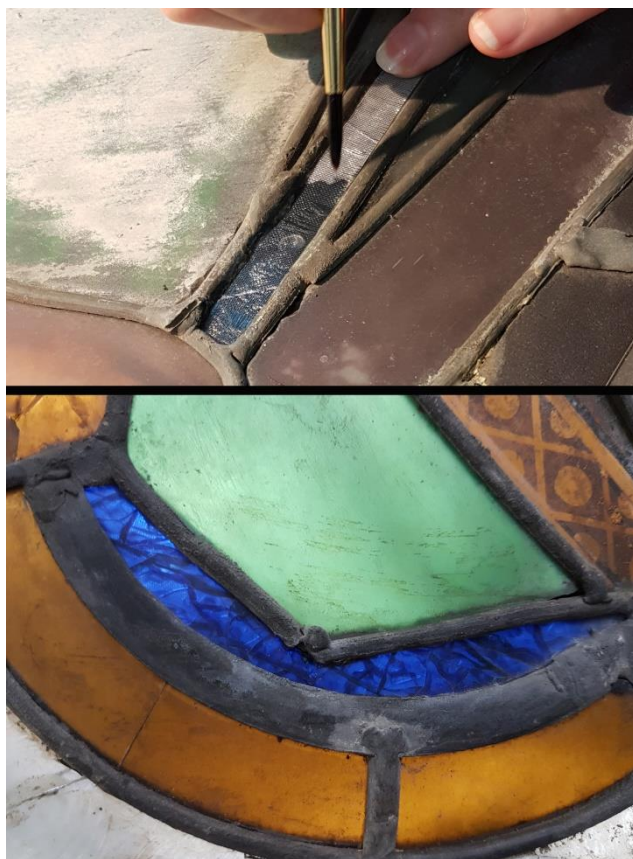
Fig.3. Craquelé consolidation technique and post treatment result in nwIII 2a  
© Vereinigte Domstifter.

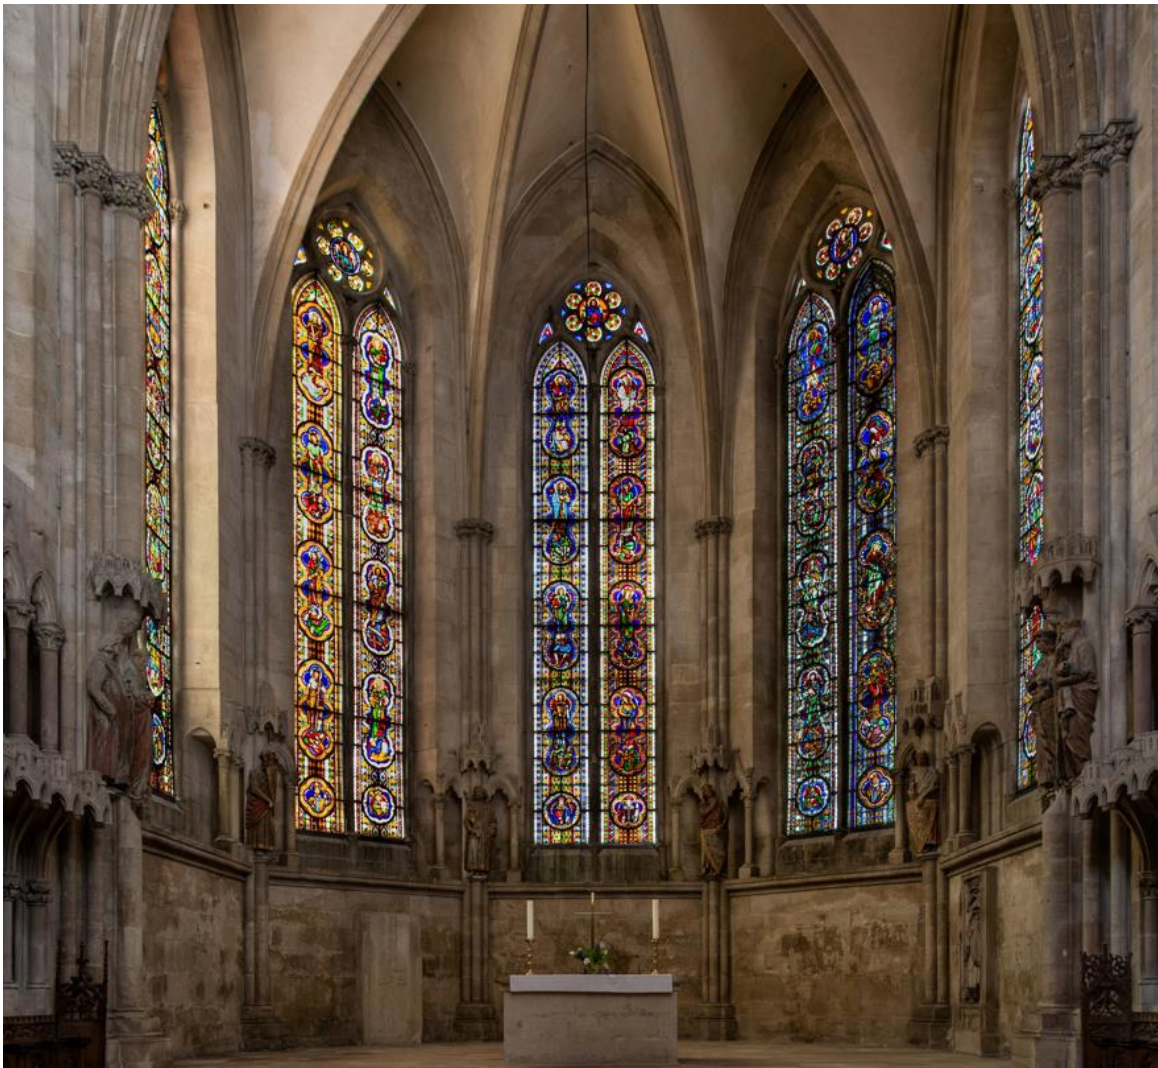
*Fig. 4. The West Choir Windows post conservation, in 2020. © Vereinigte Domstifter.*

Our methodology prioritised the immediate conservation needs of the windows. We also returned legibility to the iconography and replaced missing details with plates and infills. We stabilised the medieval glass and retained the 19th-century craquelé. All five windows are now protected with UV-filtered weathertight protective glazing and the disparity of light has been softened by the careful application of paint (fig. 4).

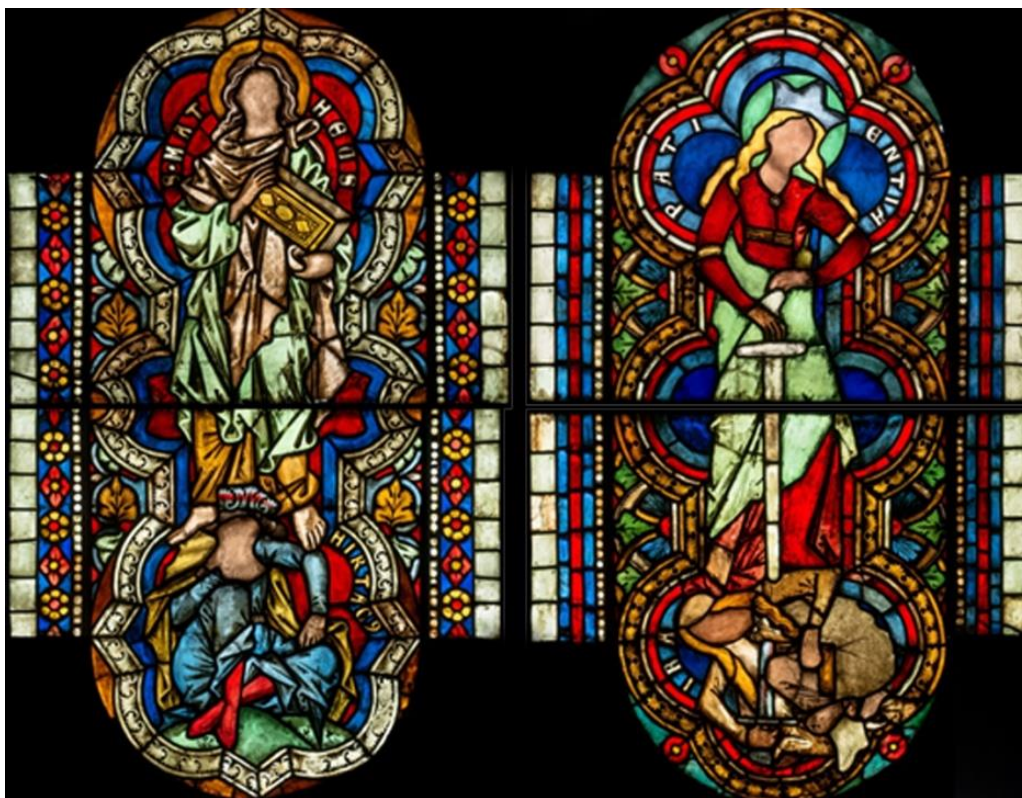
Fig. 1. Naumburg, Cathedral, nwll: 'Cloud Heads' in panels 7a, 8a, 7b and 8b, 1250/1941/1967. © Holger Kupfer.

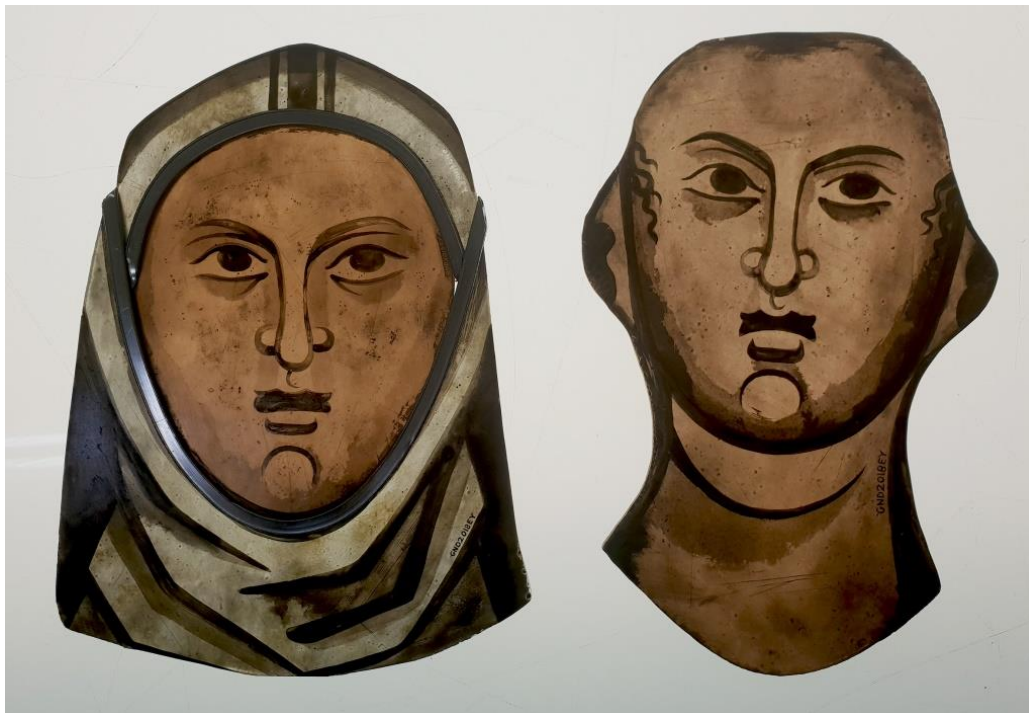
Fig. 2. Naumburg, Cathedral, nwIII: the 'Naumburg Style', St Elizabeth and St Demetrius, 2018. © Vereinigte Domstifter.

In order to replicate it, the patterns and similarities in the surviving faces were closely examined. It was discovered that the distances between the eyes, the length of the nose and width of the mouth all tended to fall within a certain range, roughly corresponding to a template. The eyes conformed to a certain shape and line style and the eyebrows were almost always the same width, thickness and line weight. This made it possible to re-imagine the lost faces according to a specific set of rules (fig. 2). The reconstructions cannot decisively predict the exact appearance or placement of lost features, but they can give an informed impression of how a head painted for the original Naumburg scheme may have looked. Furthermore, each new infill remains fully reversible.<sup>10</sup>

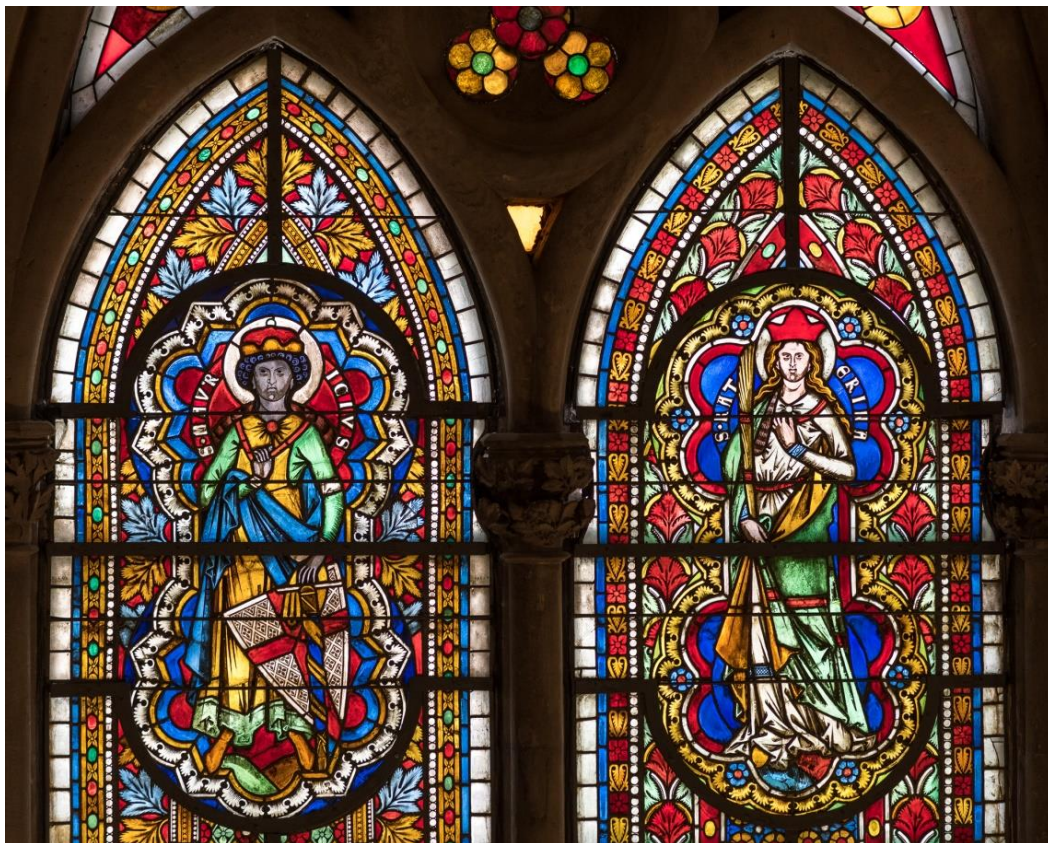
Fig. 3. Naumburg, Cathedral, nwIII: St Mauritius (with new head) and St Catherine, 1250/2018. © P. Hildebrand.

In order to stay in line with our concept and to maintain our aim of providing sensitive reconstructions in the 'Naumburg Style', the new head of St Mauritius was developed in accordance with our model. The glass colour for the figure was matched as accurately as possible to the surviving medieval material but no attempt was made to differentiate the facial characteristics from the stylistic rules we had already established (fig. 3).

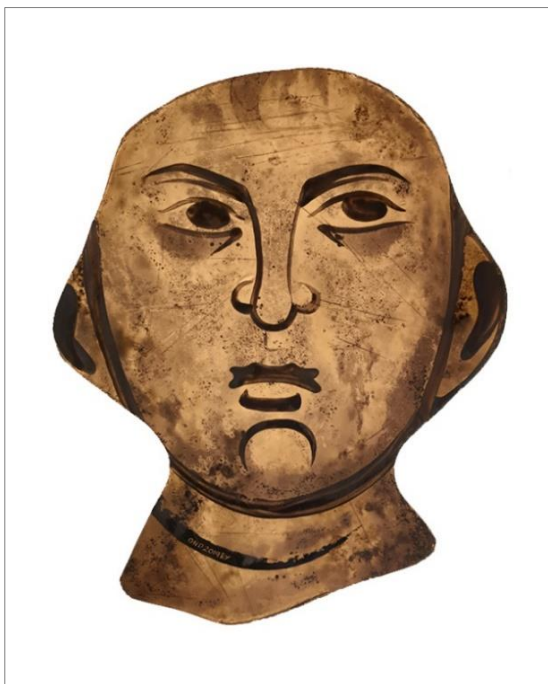
Fig. 4. Naumburg, Cathedral, swIII: development of head for St Vincent, 2018.  
© Vereinigte Domstifter.

In order to maintain the aesthetic value of swIII, to reinstitute liturgical context and to avoid the same visual disturbances caused by the neutral infill, additional modelling of the new head was necessary to achieve a level closer to its immediate surroundings (fig. 4). By adding shading layer by layer until a satisfactory level was reached, the intention was to balance the appearance of the new head within its surrounding panel, along with the rest of the figures in window swIII and the entirety of the wider scheme.

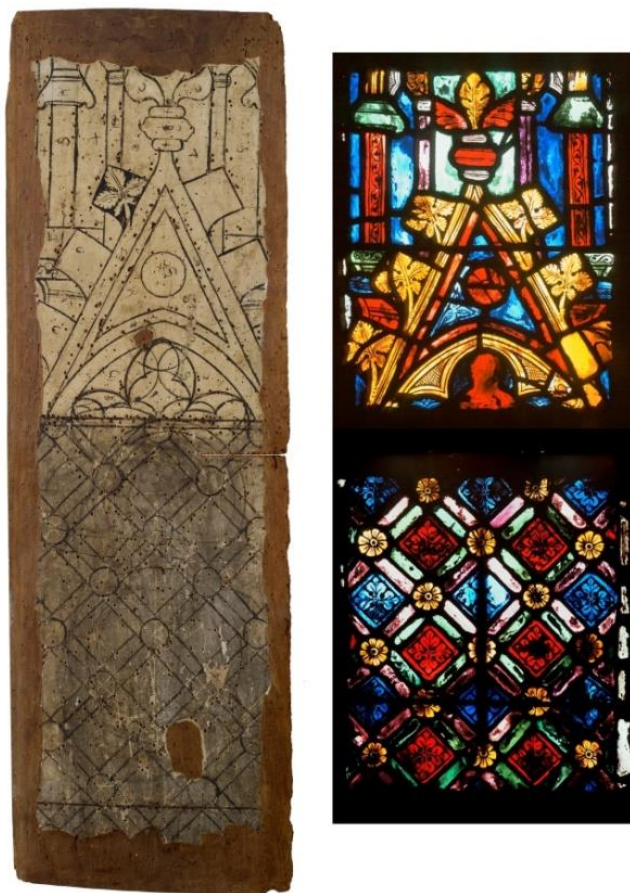
Fig. 2. Details of the white-washed table and window H-I from the presbytery.

The connection of this Marian cycle to the white-washed table has allowed us to understand the methods and techniques used in medieval glass workshops (fig 2). Combining this information with the work of Theophilus' *De Diversis Artibus*, we have deepened our understanding of a variety of processes taking place in stained glass workshops at the turn of the 12th century. During these monumental cathedral projects, the processes and organisation required would surely have been quite different to Theophilus' descriptions of traditional practices.

*De Diversis Artibus* describes processes that correspond with the evidence we see on the white-washed table in Girona. Theophilus recommends that you take a lead or tin spike and draw the perimeter measurements with rulers and compasses.<sup>10</sup> This technical drawing for Girona Cathedral's apse windows is clearly visible on the plaster preserved on the table, although much of the perimeter and lead lines laid out with black pigment have been lost. Chapter 17 of the second volume of this treatise does not tell us about teamwork, which can be deduced from a detailed examination of the table. The creation of a set of eleven large windows was not a single man's job and the hired Master Glazier would be responsible for the organisation of the studio and work, and the management of a team of professionals.

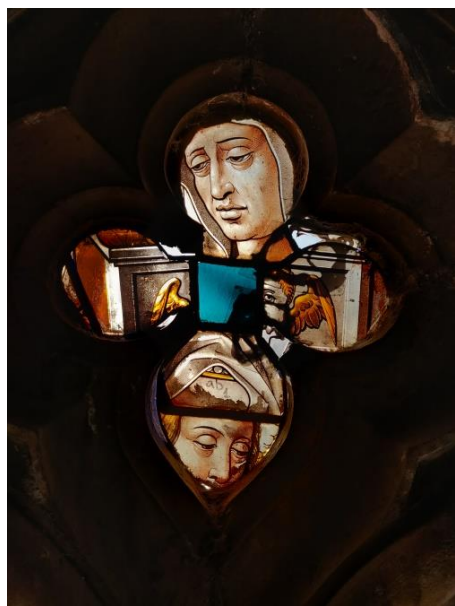
Fig. 2. Reuse of 16th-century fragments of glass in one the windows in San Marcos Church, León (Spain). © Stained glass firm 'Grisallas'®, León (Spain).

These two examples are easily recognisable by all of us, but there are many other actions or decisions clearly based on taste. Among these we could surely mention the removal (or keeping) of previous infills, stop gaps, mending leads, strap leads, etc.; patination or darkening of leads, solder, perimeter lead bands or panel frames; dying or blackening of cement or putty; the level of retouching with cold paints; even the degree of acceptable cleaning of a panel can be different from one conservator to another, or between different studios (fig. 2).

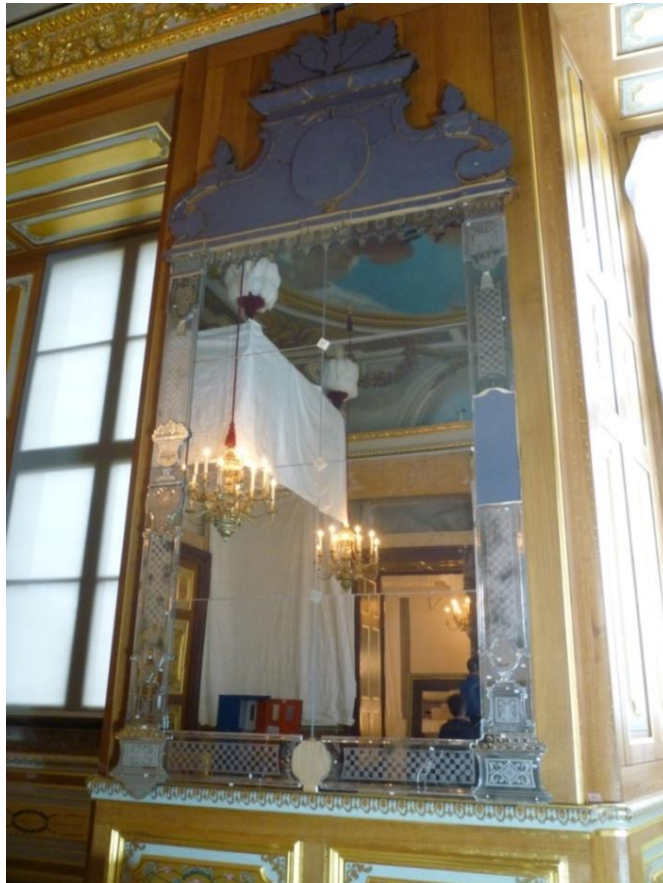
Abb. 4. Teilaufbau  
des fertigen  
Spiegels im  
Audienzzimmer.

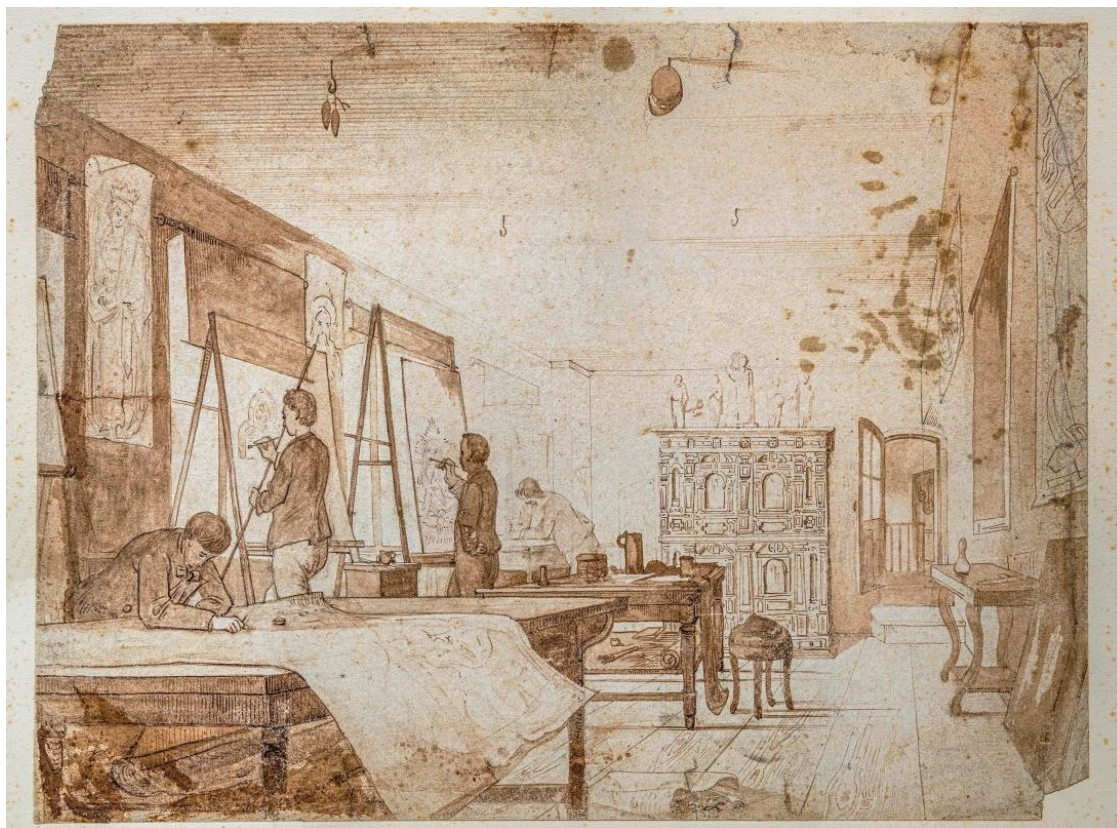
Abb. 2. Werkstattzeichnung, unbekannter Autor, Privatbesitz. © I. Geiger-Messner, LAD.

Auf einer Zeichnung, die einen interessanten Einblick in die Glaswerkstatt Mittermaiers gibt, ist die Verwendung der Kartons während des Herstellungsprozess zu sehen (Abb. 2).

Erst wurde ein maßstabsgetreuer Papierentwurf entsprechend dem Aufmaß des Fensters gefertigt, der die figürliche Darstellung der Kartons übernimmt. Dieser sog. Bleiriss wurde entsprechend dem Gesamtkonzept der Fenstergestaltung mit Bordüren, Stiftungsfeldern im Sockelbereich und Hintergrundgestaltung weiter ausgestaltet. Für die Ornamentik standen der Werkstatt verschiedene Vorlagen zur Verfügung. So ist bekannt, dass Prof. Eisenlohr aus Karlsruhe Mittermaier 1850 eine Anzahl seiner bisher erschienenen Ornament-Zeichnungen zum Gebrauch zusendete.<sup>7</sup>

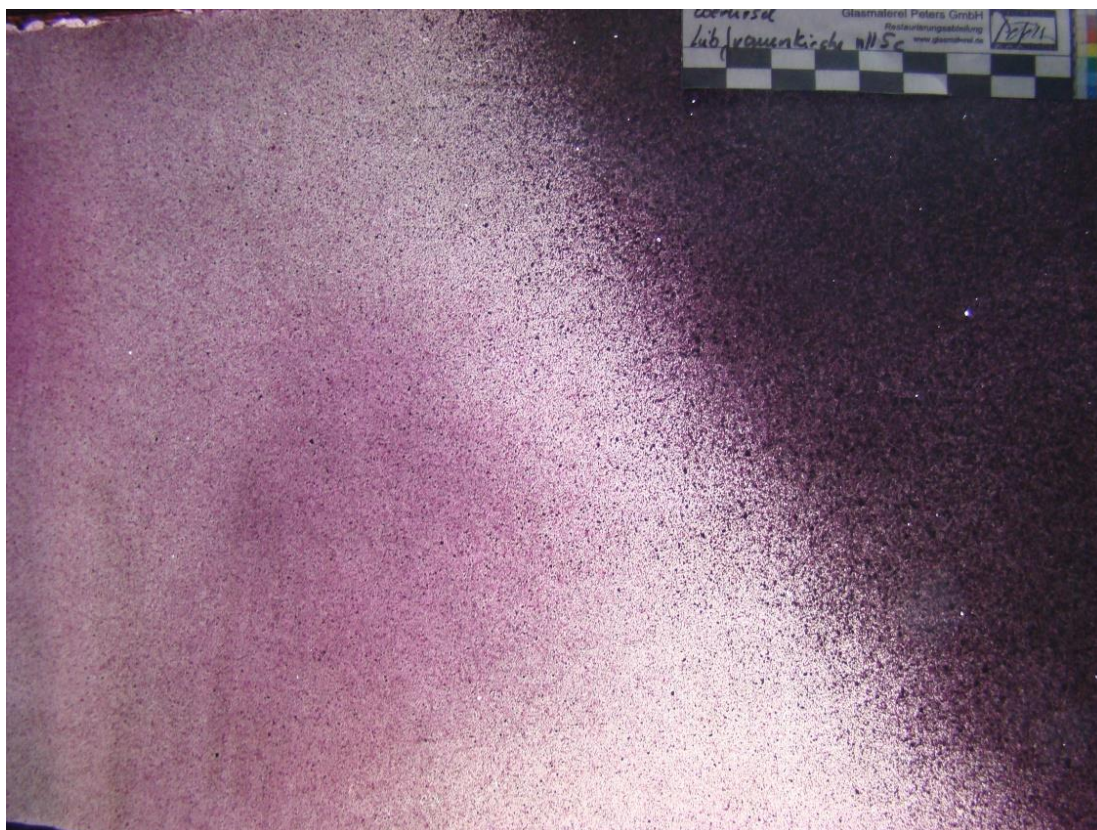
Fig.3 Oberusel / Taunus, Liebfrauenkirche, Detail der Airbrush-Technik (nH 5c), G. Hoke, 1967.  
© Glasmalerei Peters GmbH, Paderborn.

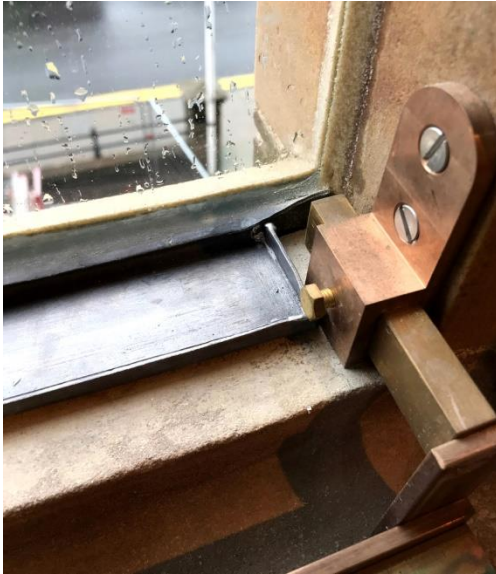
Fig. 1. Lerwick Town Hall, Shetland, west elevation detail showing external glazing, mortar covered with burnt sand mastic "skin", bottom slide bar system placed vertically on stone cill, the leg extension to accommodate any overall height changes, and the lead condensate tray, 2017. © Cannon-MacInnes.

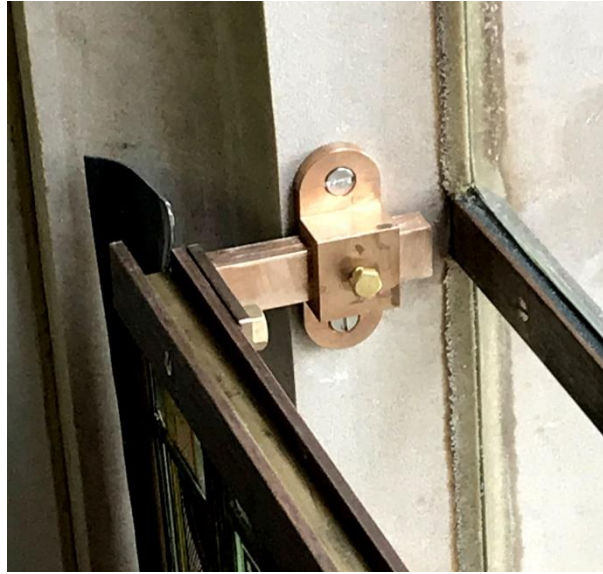
Fig. 2. Lerwick Town Hall, Shetland, west elevation detail showing external glazing, mortar covered with burnt sand mastic "skin", vertical slide bar system placed vertically on new stone mullion, the manganse bronze support bar, and a fully conserved "middle" panel in place, 2017. © Cannon-MacInnes.

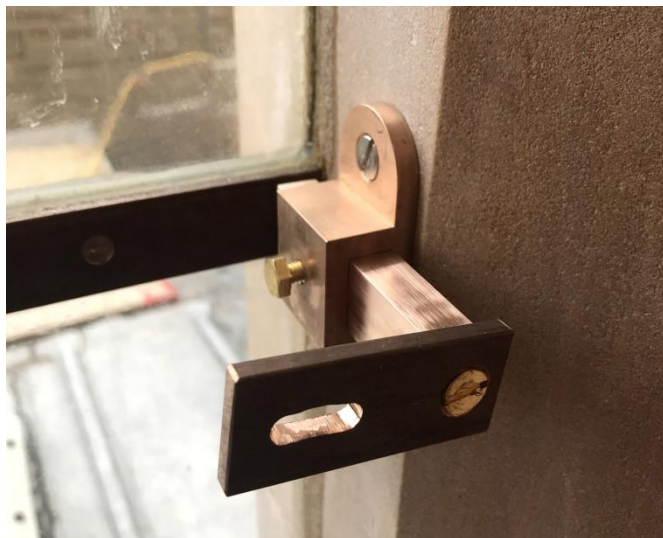
Fig. 4. Lerwick Town Hall, Shetland, south elevation detail showing the internal slide bar, which allows the whole system to be finely tuned to fit perfectly. Each panel can be adjusted on site, slightly up, down, in, out, right or left, 2017. © Cannon-MacInnes.

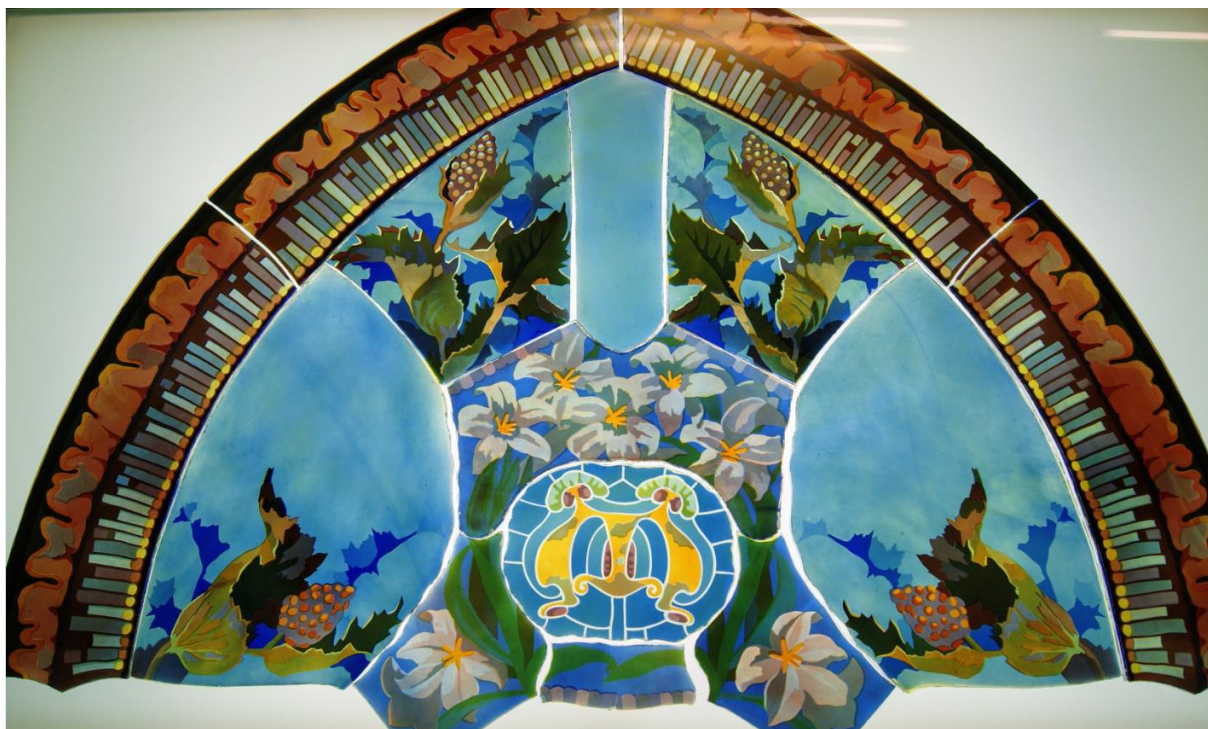
*Fig. 2. The glass pieces of the top panel, once the lead had been removed, at the workshop. We can observe the nice result of the good acid etching work. However, also we can see how the sinuous shape of the glass pieces don't always fit well with the shape of the glass piece beside. Stained-glass window in the Immaculata Chapel on Montserrat Monastery (1910). Paloma Somacarrera, 2018.*

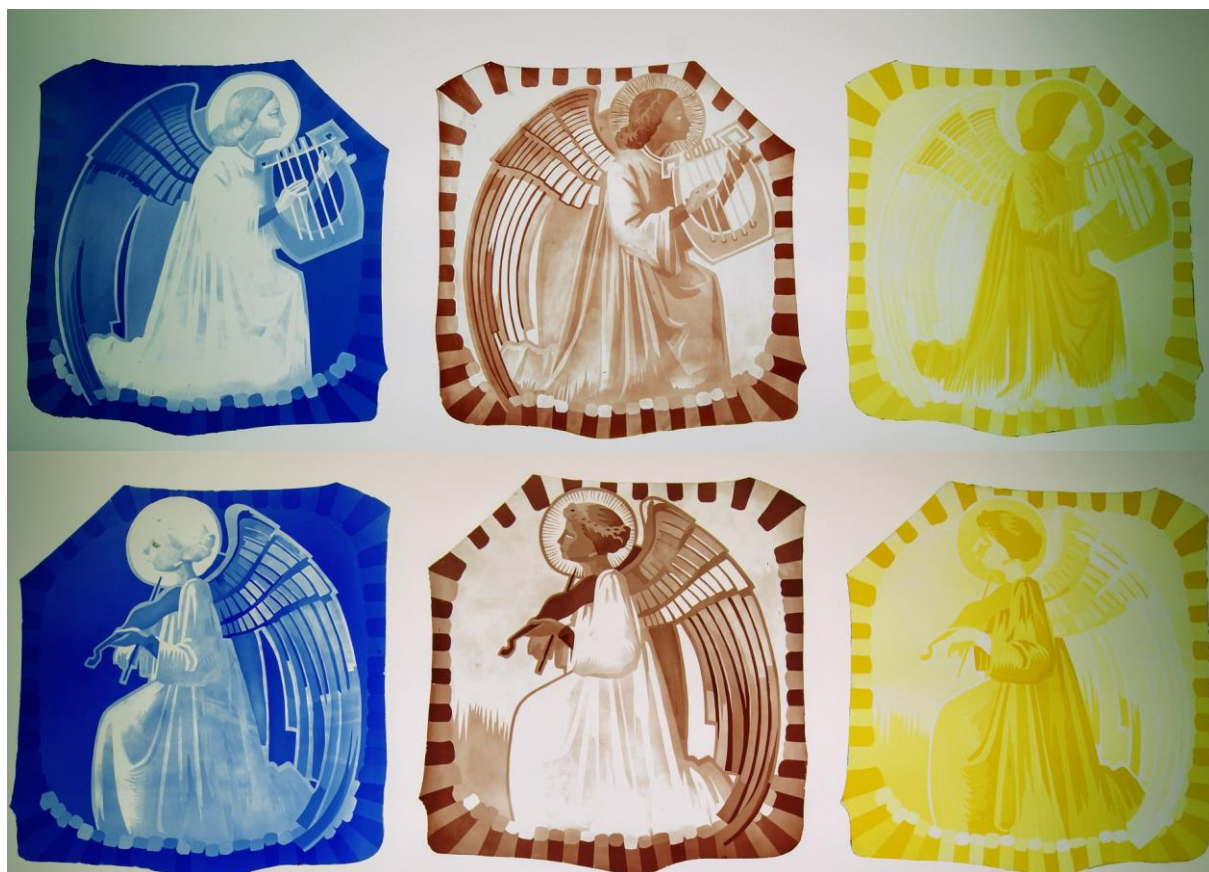
*Fig. 3. The musician angels from the top row.  
The figures show us different ways to work on them. Stained-glass window in the Immaculata  
Chapel of Montserrat Monastery (1910). Paloma Somacarrera, 2018.*

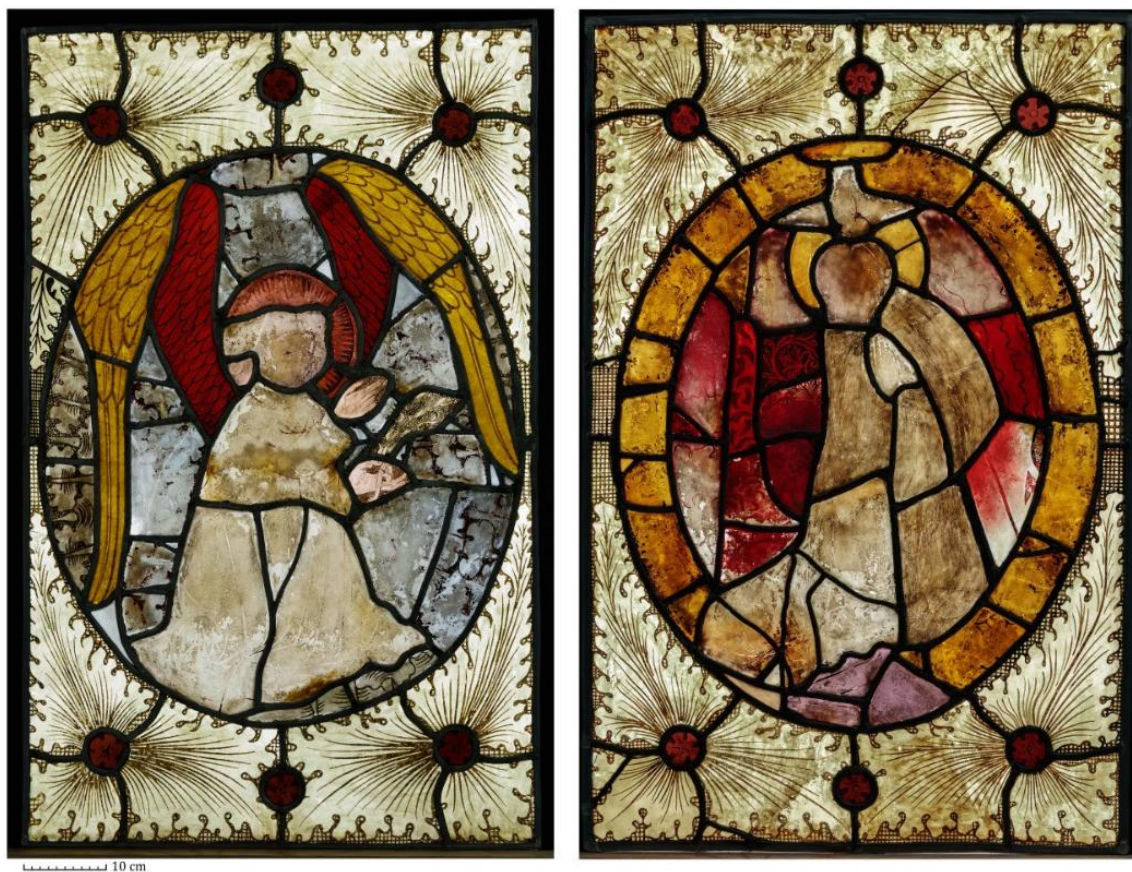
Fig. 1. Kraków, National Museum and Dominican Monastery, stained-glass panels depicting the Angel and the Virgin Mary at the Annunciation, c.1440. D. Podosek, © Corpus Vitrearum Polska.

The scene of the *Annunciation* consists of a left panel representing the Angel<sup>5</sup> and a right panel depicting the Virgin Mary<sup>6</sup> (fig. 1). Probably they originally decorated the windows of the chapel of the Annunciation (currently the Rosary Chapel), erected around 1440. However this cannot be verified due to the lack of any information about the appearance of the Gothic chapel.<sup>7</sup> Presumably in the 17th century the stained-glass windows were moved from church windows to the cloisters windows.<sup>8</sup>

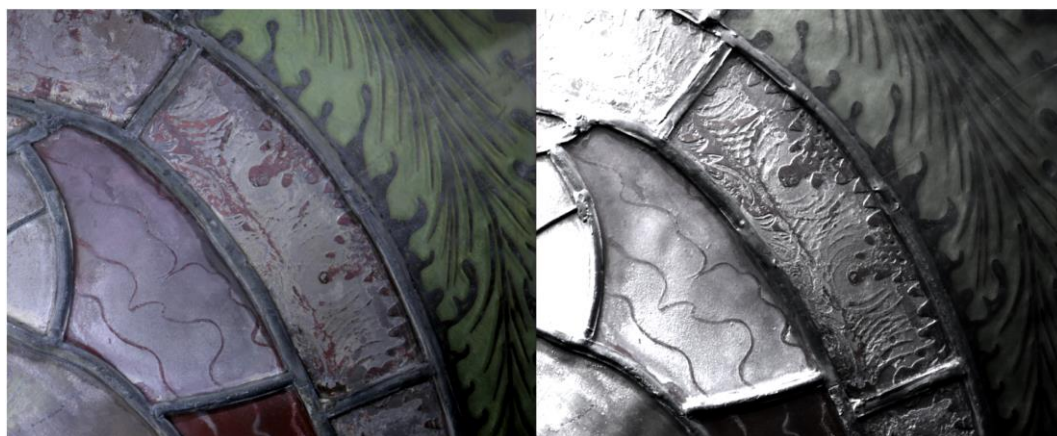
Fig. 3. Photograph in reflected light and RTI SE image (HSH). E. Bernady.

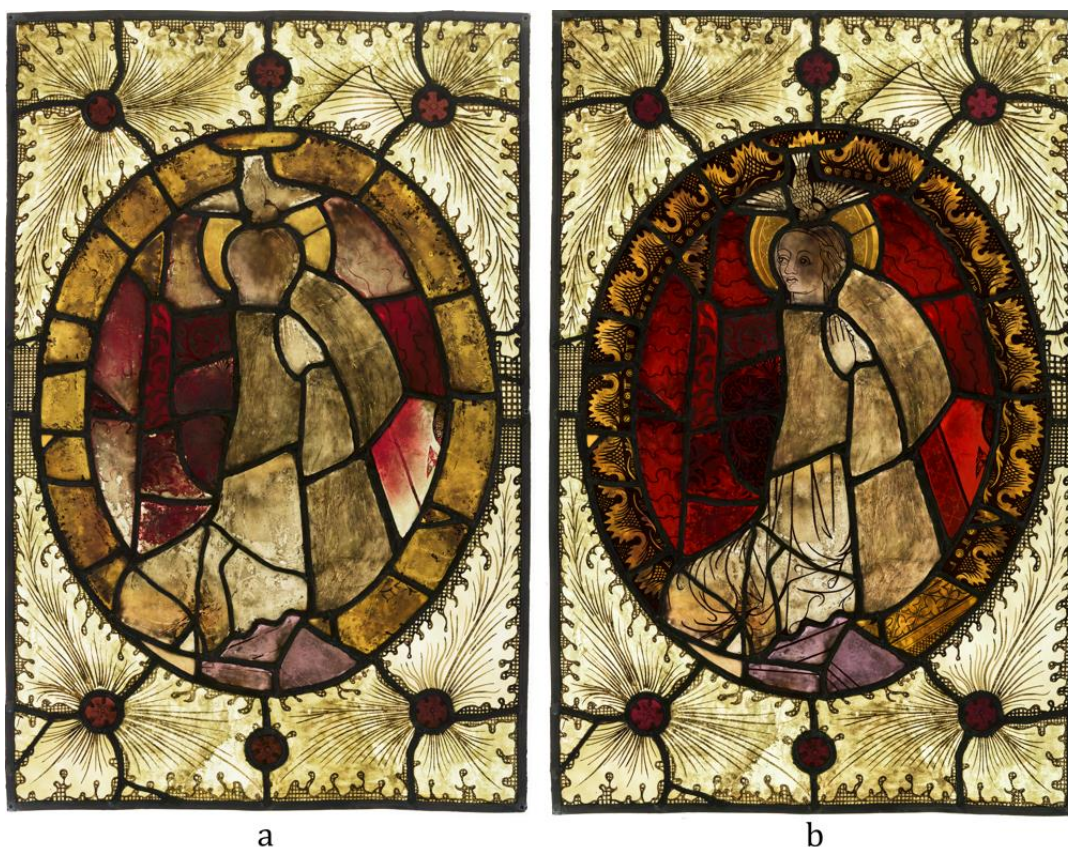
Fig. 4. Digital reconstruction of the Virgin Mary: (a) orthophoto map; (b) digital reconstruction of the contour lines and restoration of red colour of background glass panes. Photo: P. Gąsior, B. Mitka, image: E. Bernady.

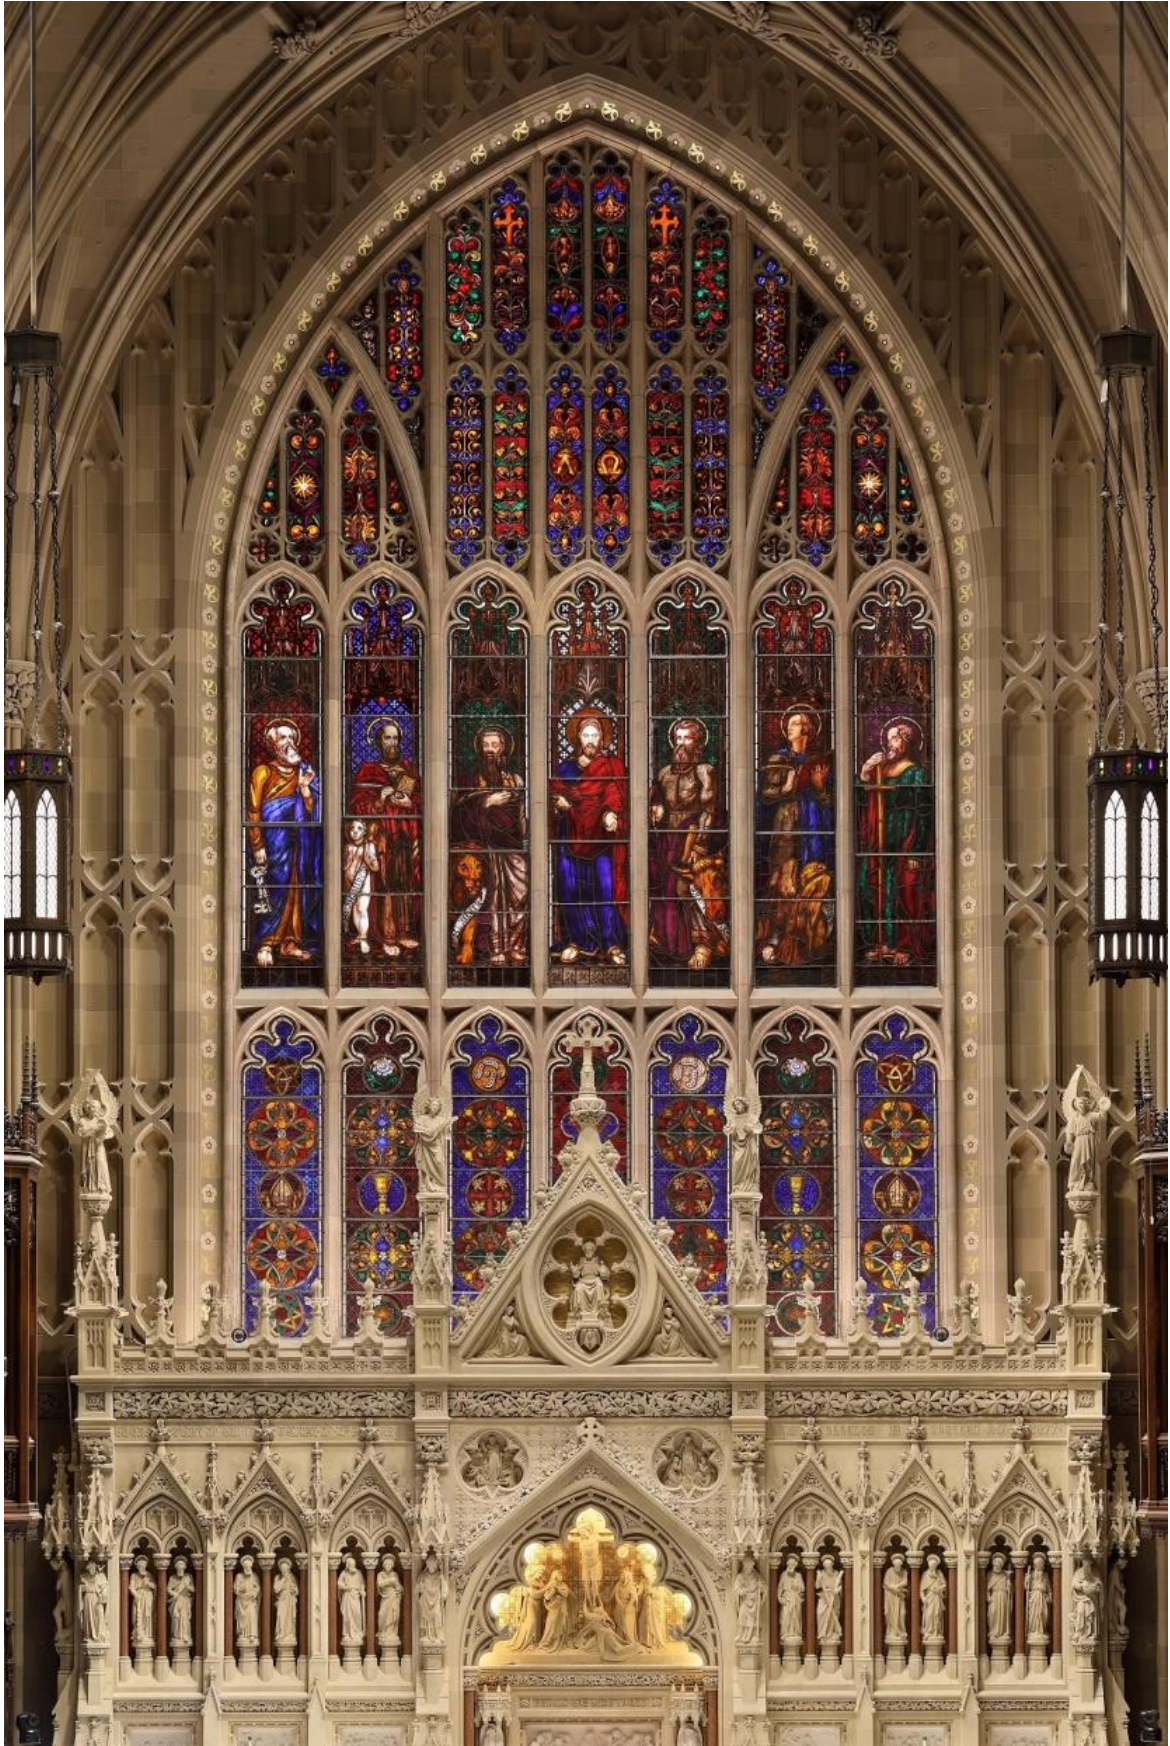
*Fig. 2. Trinity Church, window C219, Chancel stained-glass window. 2020.  
Photograph by Whitney Cox, reprinted with permission of Trinity Church.*

The multiple interventions undertaken on the Chancel window were obvious by the size and condition of the lead and further evidenced by information in the archives and graffiti on the exterior of the stained glass. Noticeable replacement pieces permeate the window, as in the example of St Matthew’s head. The window had also been cold painted on many occasions with dark paint and/or shellac. In

some areas, the cold paint was applied across the lightest areas of the window *in situ* and extended over the lead came. A photochrome from c. 1901 shows the presence of exterior glazing, suggesting that the abundance of light coming through the window required mitigation.<sup>21</sup> This “smoke glass” was later removed and cold paint was applied, possibly to minimize glare. The glass paint was discovered to be fragile, and the fragility likely factored into the decision to apply cold paint in the past. The various applications of cold paint throughout the window have been affected by moisture and natural deterioration, causing a blotchy and inconsistent appearance.

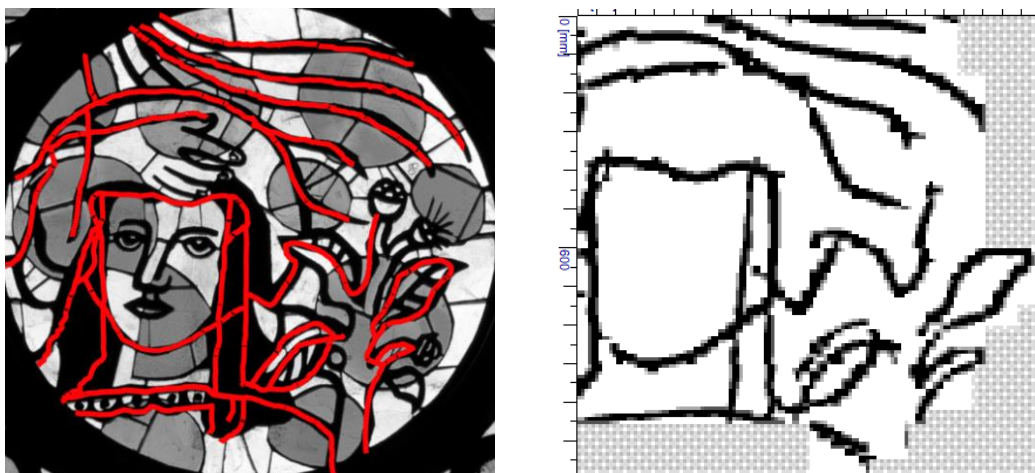
Fig. 3. Position des armatures dans le médaillon de l'Annonciation à Courfaivre déterminée avec un aimant (à gauche) et à l'aide d'un profomètre Hilti Ferroscan PS200 avec analyse et interprétation automatisées (à droite). © Auteurs.

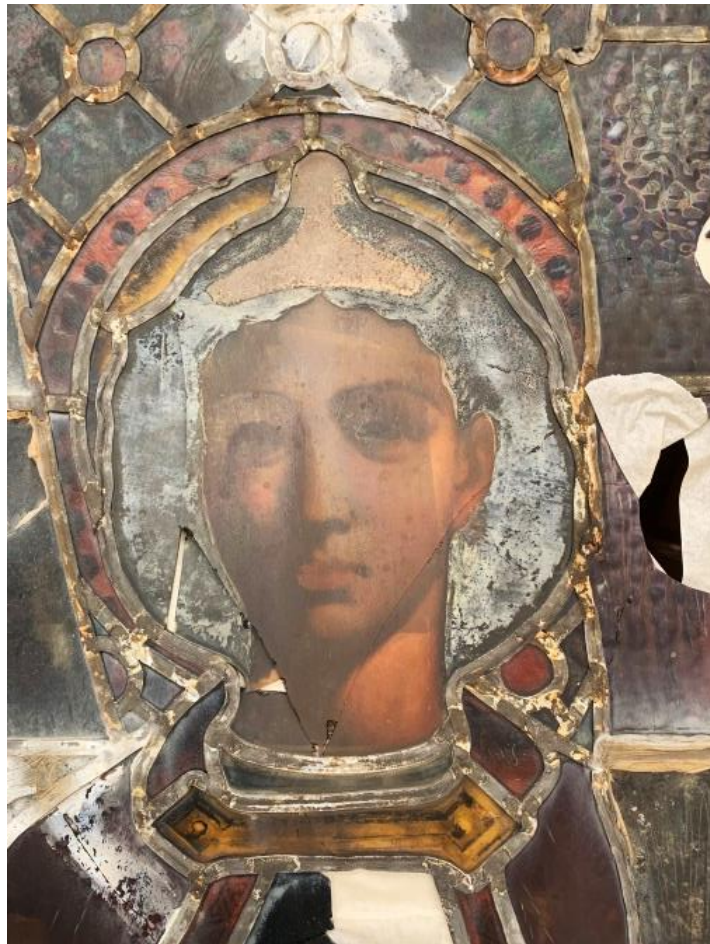
Fig. 1. Typical white aspect of enamel on a face painted by Amigó Studio, 1903. Sant Jaume of Calaf Church.

Enamel is a crucial part in the conservation of the windows of this period, however the reasons for each alteration are not yet clear. This paint plays a relevant role in the aesthetics of the windows,

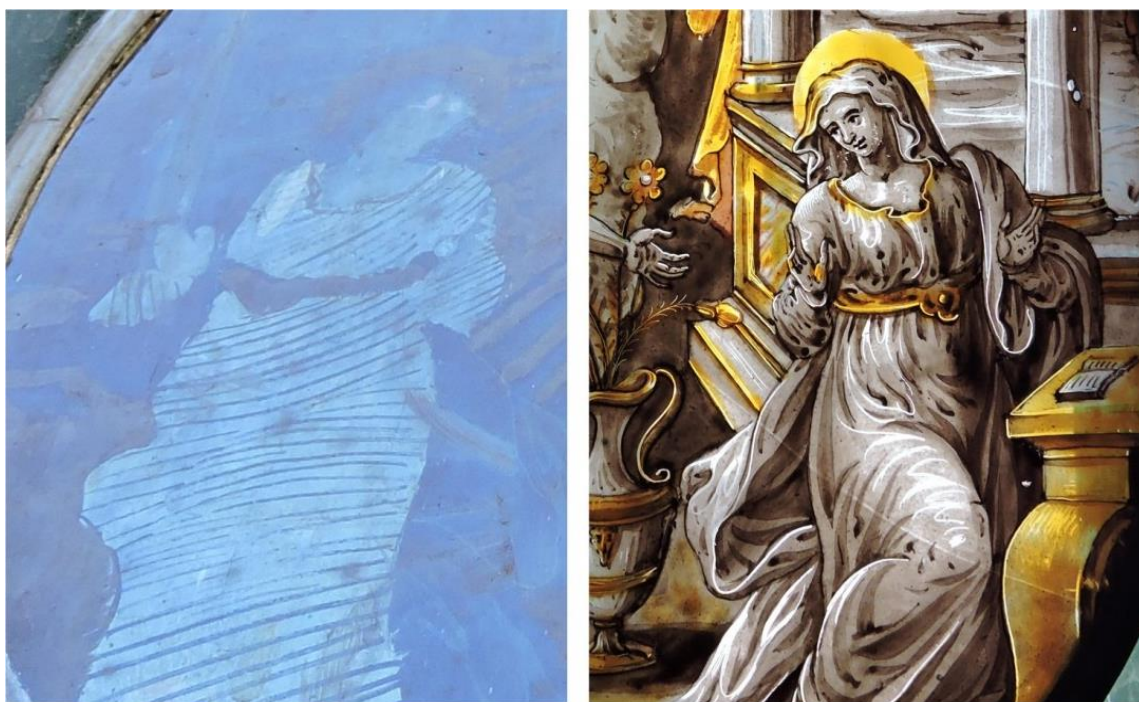
Fig. 2. Ghent, Belgium, STAM Museum: panel showing a view from reverse and front side of a detail of the Annunciation, from Southern Netherlands, second half of the 16th century (09011). © STAM Museum.

Firstly, It seems important to observe alterations of sanguine and carnation, to work towards understanding the behaviour of these paints on stained glass over time. During visits to various museums, some very specific damage phenomena have been observed. It has been in particular the case for the stained-glass collection held at the STAM museum in Gent, where observations were made by glass painter Anne-Catherine Perreau and conservator and art historian Aletta Rambaut.

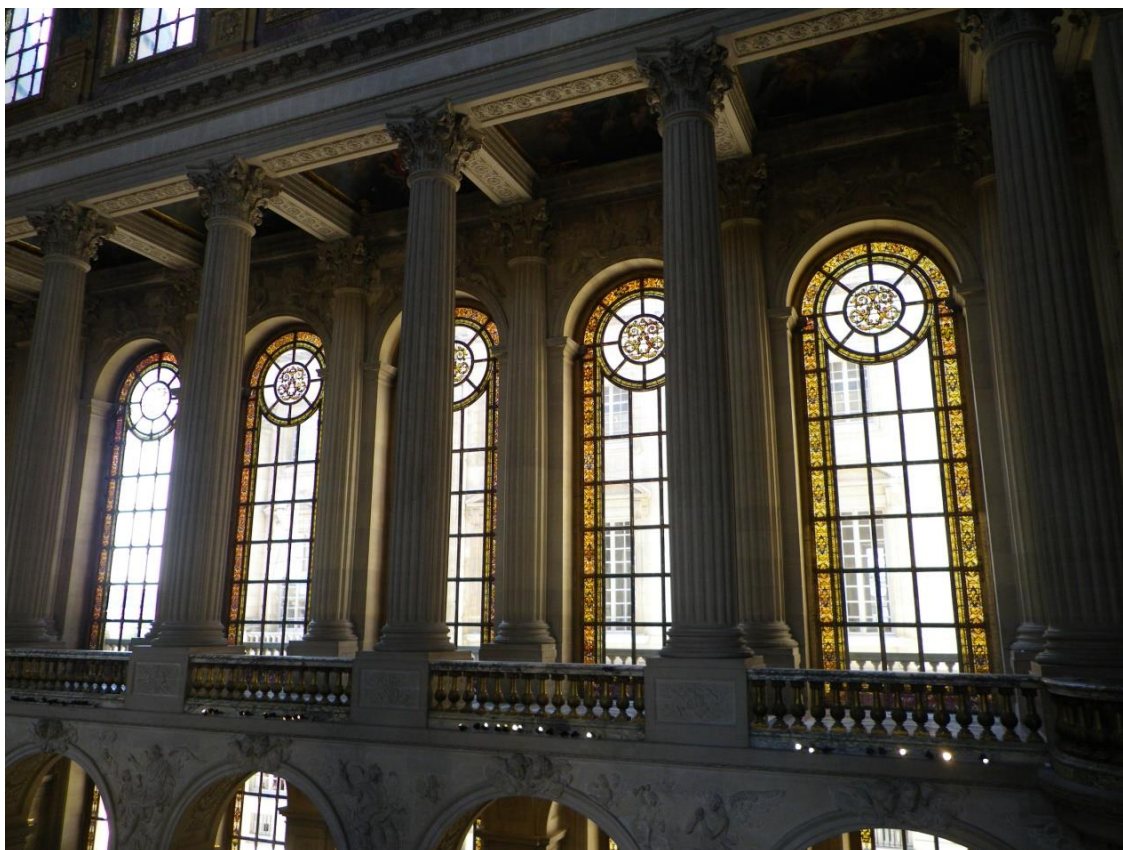
*Fig. 1. Vue intérieure des vitraux de la chapelle royale de Versailles avant la restauration. Chaque verrière est composée de grandes glaces incolores et d'une bordure de panneau en verre mis en plomb.*  
© Claudine Loisel, 2015.

Construite entre 1700 et 1710, la chapelle royale du château de Versailles comporte sur ces trois niveaux de baies, 24 grandes baies entre l'attique (niveau haut) et la tribune (niveau intermédiaire) et un peu plus de 10 baies en rez-de-jardin (fig. 1). Elles sont composées de verres incolores, appelés glaces, entourées de bordures en verre mis en plomb. La serrurerie métallique très ornementée est constituée de parcloes vissées. Lors de la commande des verres pour la chapelle royale, comme pour
