**Preserving Identity**

**11th Forum for the Conservation and  
Technology of Historic Stained Glass  
Girona – Barcelona, 7–9 July 2022**

**Organized by the Catalan Committee  
of the Corpus Vitrearum  
in Association with the  
International Scientific Committee for the  
Conservation of Stained Glass (ISCCSG)**

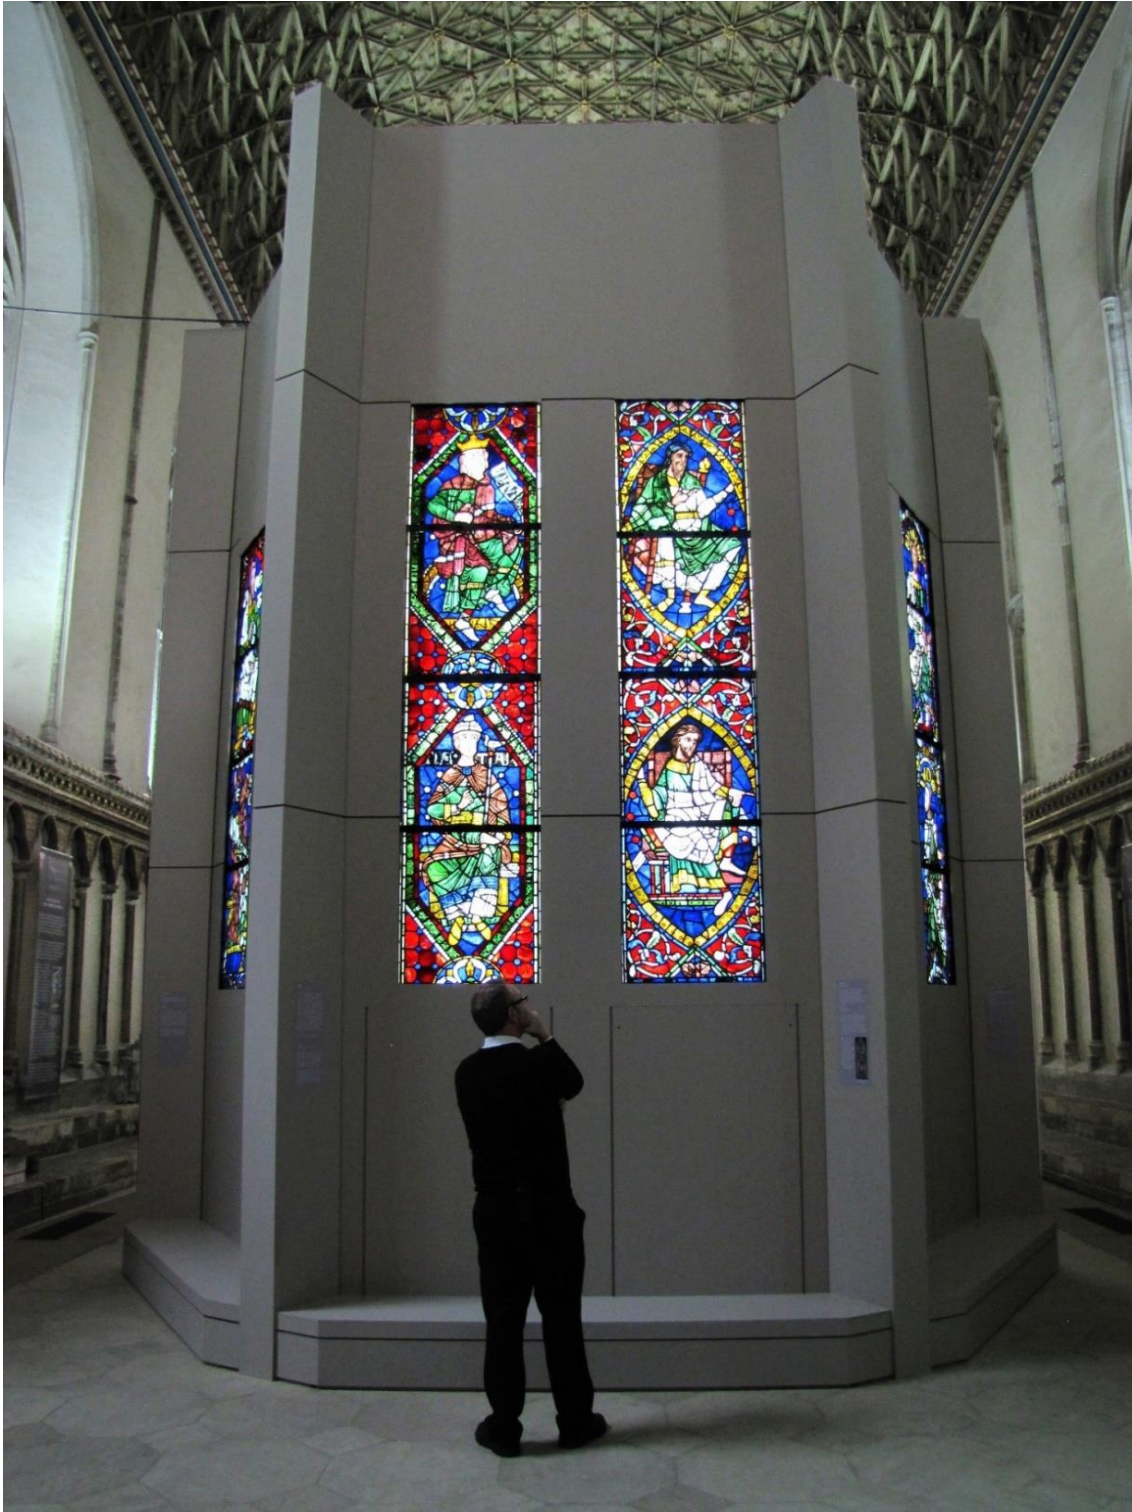
*Fig. 2. The Ancestors, free-standing display of Canterbury windows, developed by the Metropolitan Museum of Art for the exhibition Radiant Light, 2014-2015. Reproduced courtesy of the Chapter, Canterbury Cathedral.*

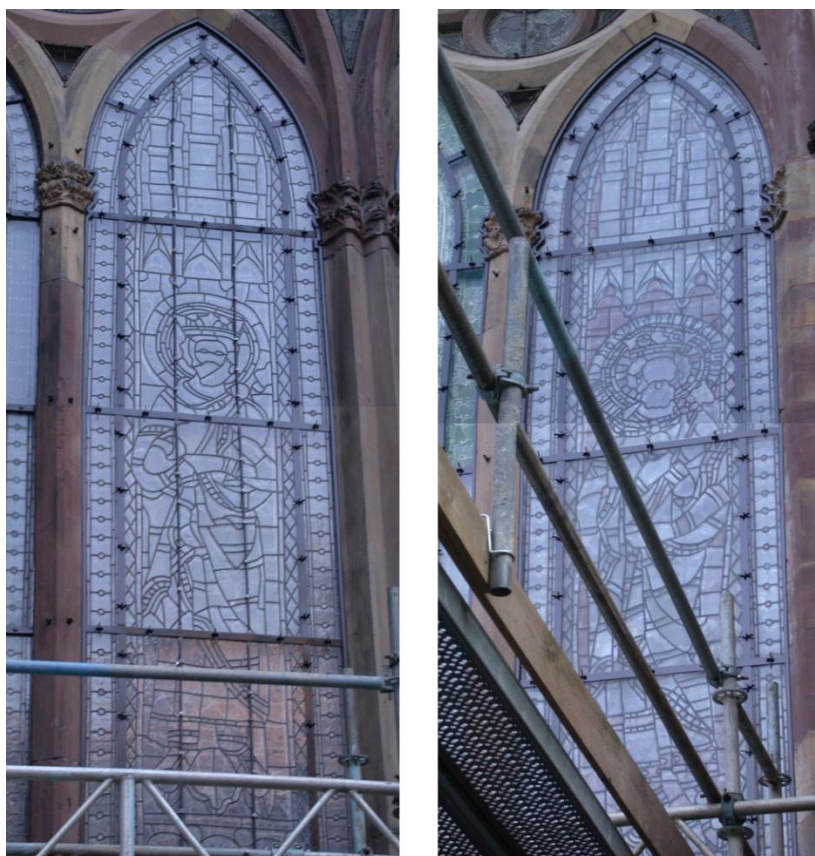
Fig. 1. Strasbourg, cathédrale Notre-Dame, prototype des verrières de protection, à gauche en verre mis en plomb et à droite en verre thermoformé. © LRMH, Claudine Loisel, 2005.

En 2005, dans le cadre de la restauration des vitraux de la cathédrale de Strasbourg, un prototype comprenant ces deux modèles de verrières de protection a permis de comparer leur effet esthétique *in situ* et de décider à échelle réelle (fig. 1). La verrière de protection en verre mis en plomb sera sélectionnée.

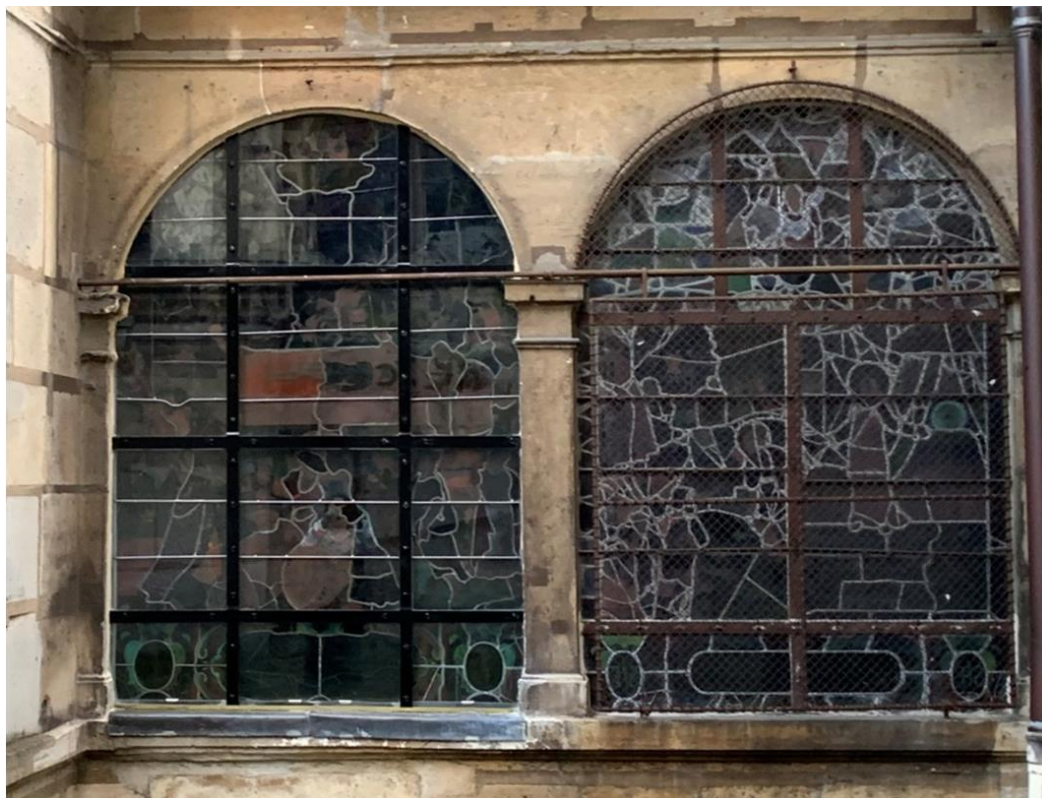
Fig. 2. Paris, église Saint-Étienne-du-Mont, vitraux du charnier, à gauche avec verrière de protection en verre incolore feuilleté, à droite avec grillage et sans verrière de protection.  
© Manufacture Vincent-Petit, 2019.

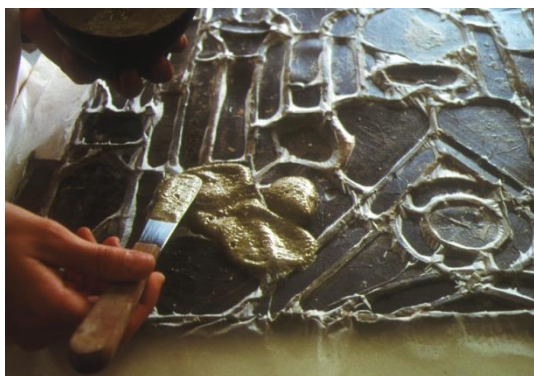
Fig. 2. Application of zeolite dressing with AB57 to remove the lime coating. Photo: Josep Gri.

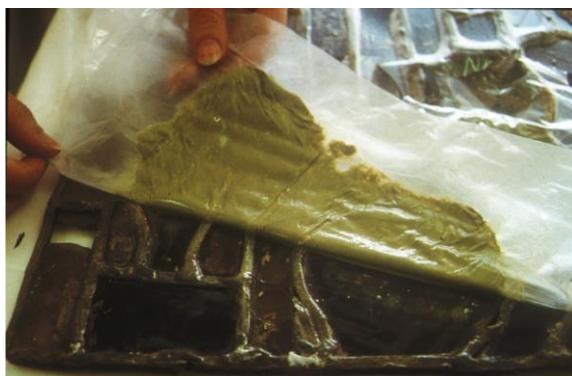
Fig. 3. Removal of the dressing by lifting the Japan paper. Photo: Josep Gri.
